## Service description

Product: VF253	Service description no: 2412-S001	Ver: 1
-------------------	---	-----------

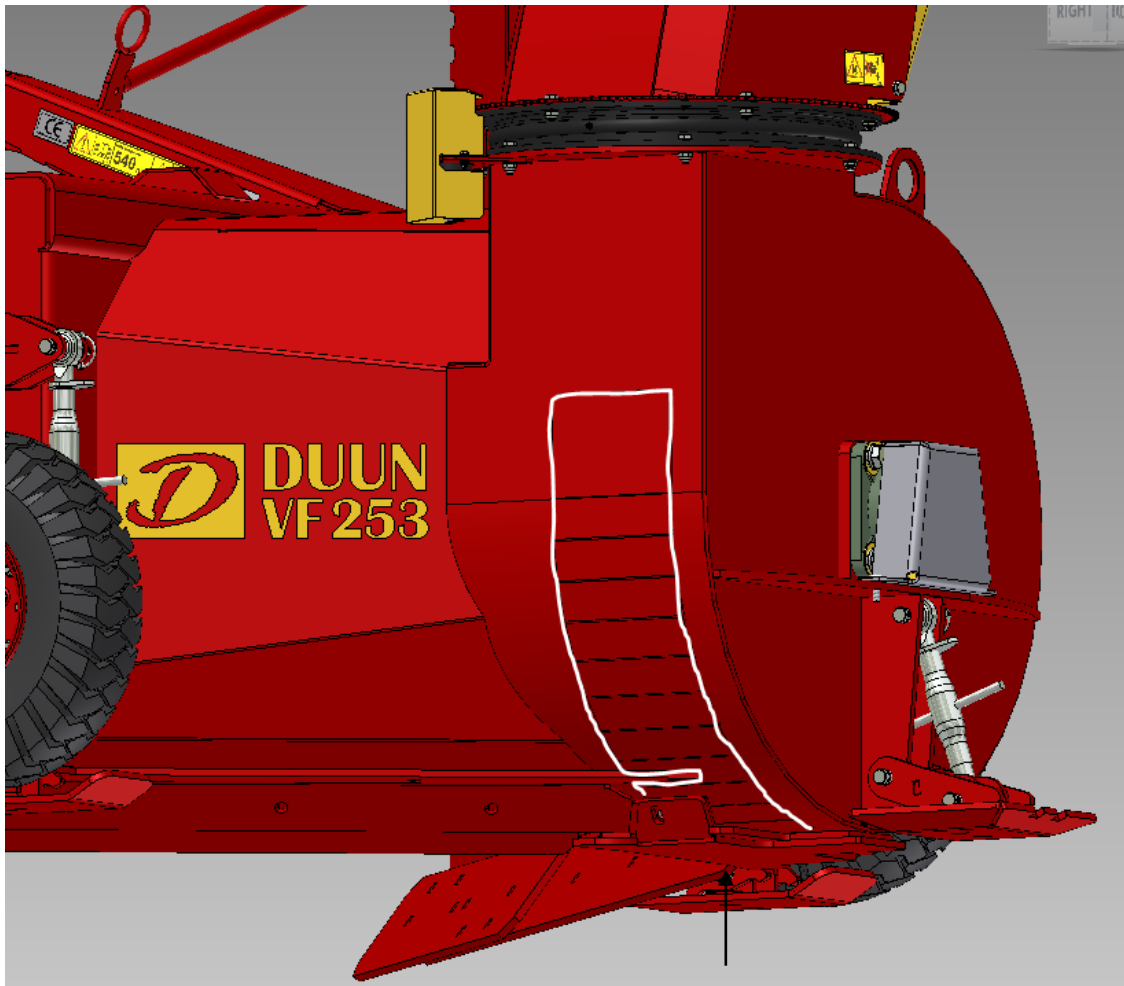
- Hole in a fan housing.

- Gravel and sand in the snow have worn holes in the fan housing.

- Insert a fine of 10mm hardox in the area that is worn. Item number [125129050](#).

- Release the wear steel under the fan housing. Marked by the arrow.
- Measure the bottom and mark the fan housing where it should be welded.
- Cut out the marked area. Cut out around the brace and sand this after to get the new insert plate in place.
- Point the new insert plate firmly and weld it after. Also weld the brace to the new bottom.
