Service description

Product: VF240	Service description no: 2514-S001	Ver: 1
-------------------	---	-----------

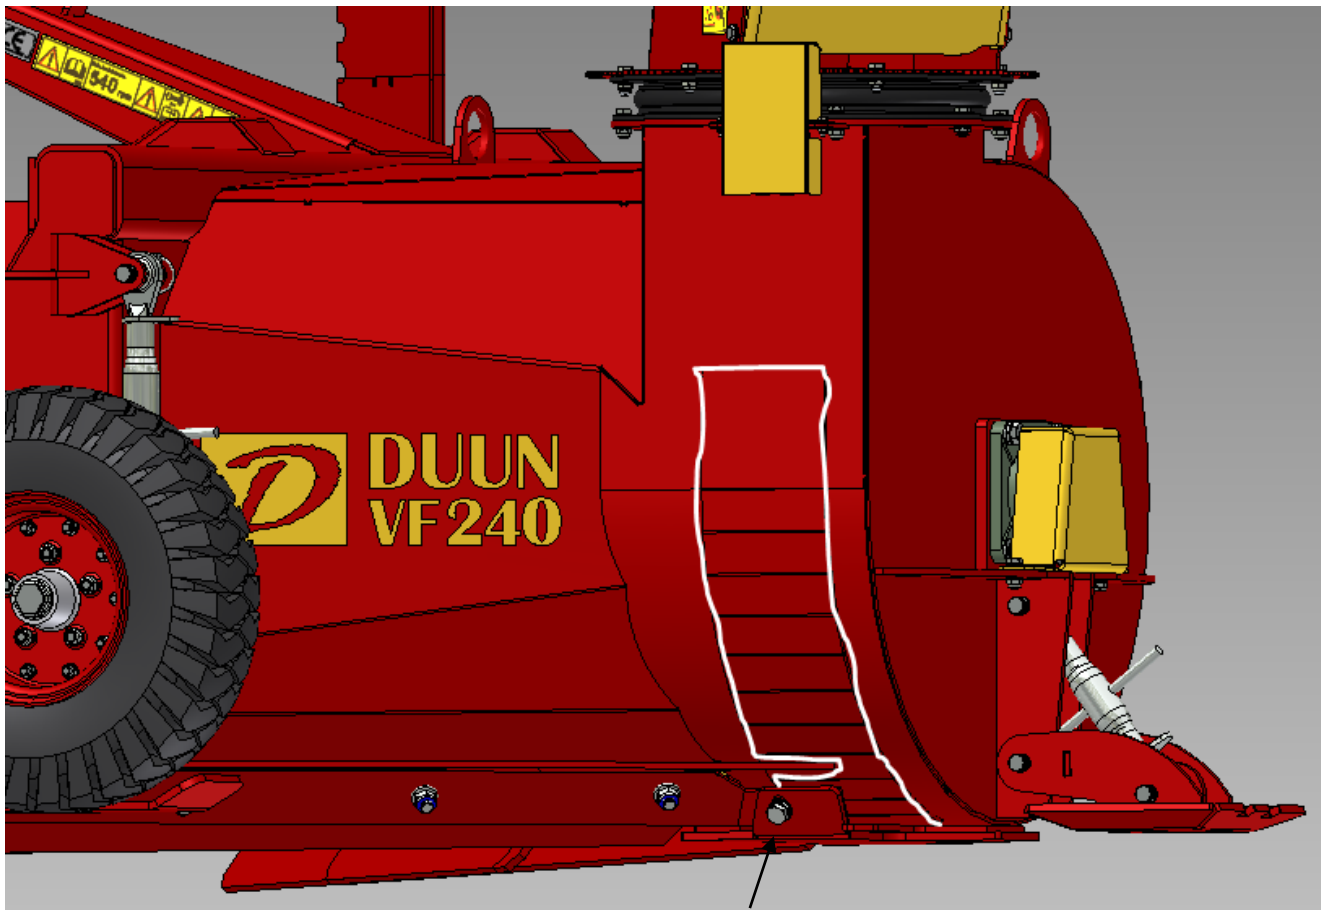
- Hole in a fan housing.

- Gravel and sand in the snow have worn holes in the fan housing.

- Insert a plate of 10mm hardox in the area which is worn. Product number 125149050.

- Release the wear steel under the fan housing. Marked with the arrow.
- Measure the bottom and mark the fan housing where it should be welded.
- Cut out the marked area. Cut out around the brace and sand this after to get the new insert plate in place.
- Point the new insert plate firmly and fully weld after. Also weld the brace to the new bottom.
