Service description

Product: SP200	Service description no: 3112-S009	Ver: 1
-------------------	---	-----------

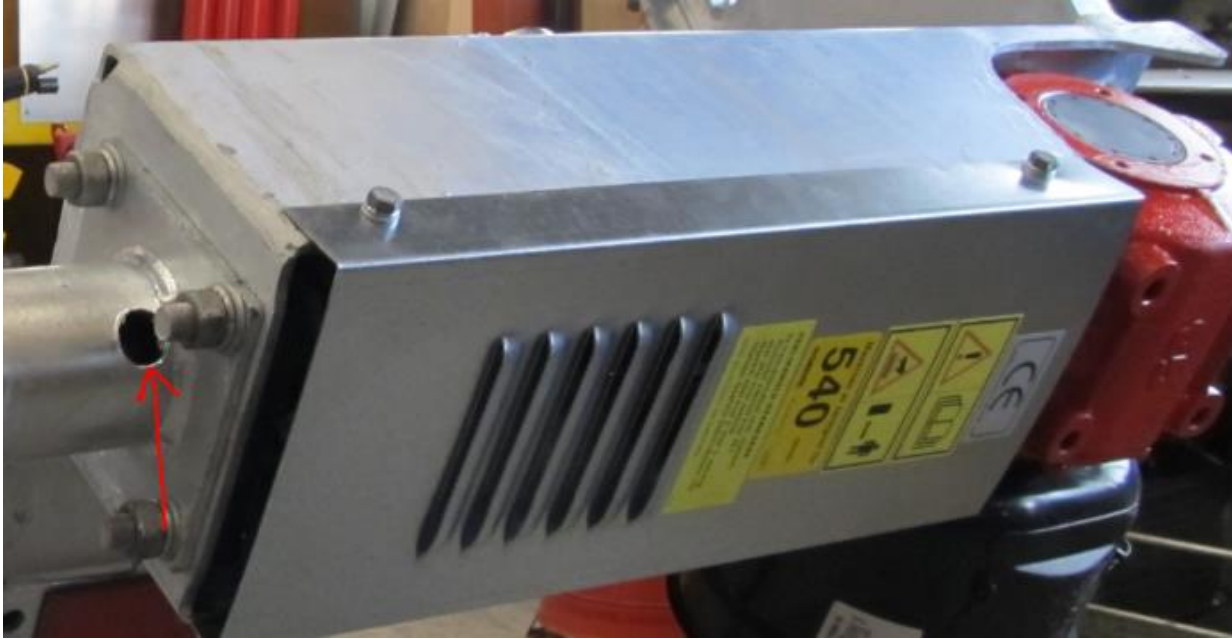
Slurry mass comes out of the upper part of the cover tube towards the gearbox.

The drainage holes in the cover tube are clogged. The cover tube is full of slurry.

Flush out drainage holes.
