Service description

Product: SP200	Service description no 3112-S010	Ver: 1
-------------------	--	-----------

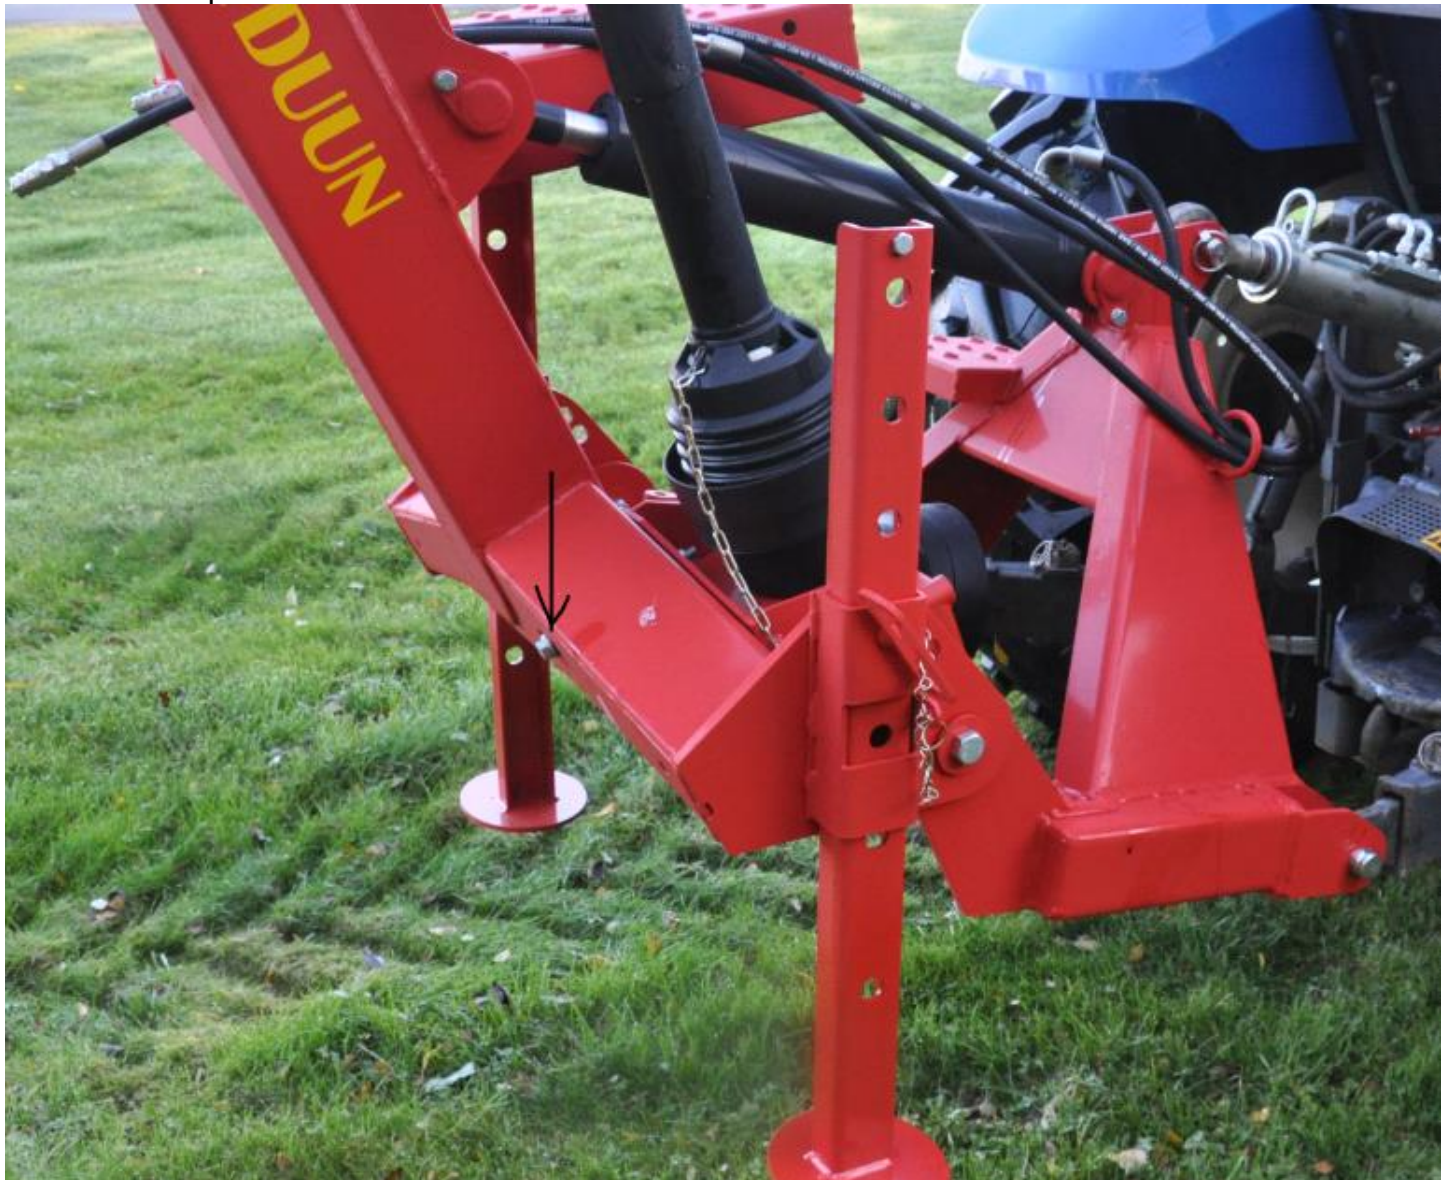
The double gearbox at the bottom of the pump holder is loose.

The part of the double gearbox that points away from the tractor must NOT be completely screwed in.

The gearbox is attached to the bracket that should fit loosely against the pump attachment. This is to avoid tension in the gearbox during start-up and moving the pump. DO NOT tighten the screw marked in the picture.
