Service description

Product: SP200	Service description no: 3112-S013	Ver: 2
-------------------	---	-----------

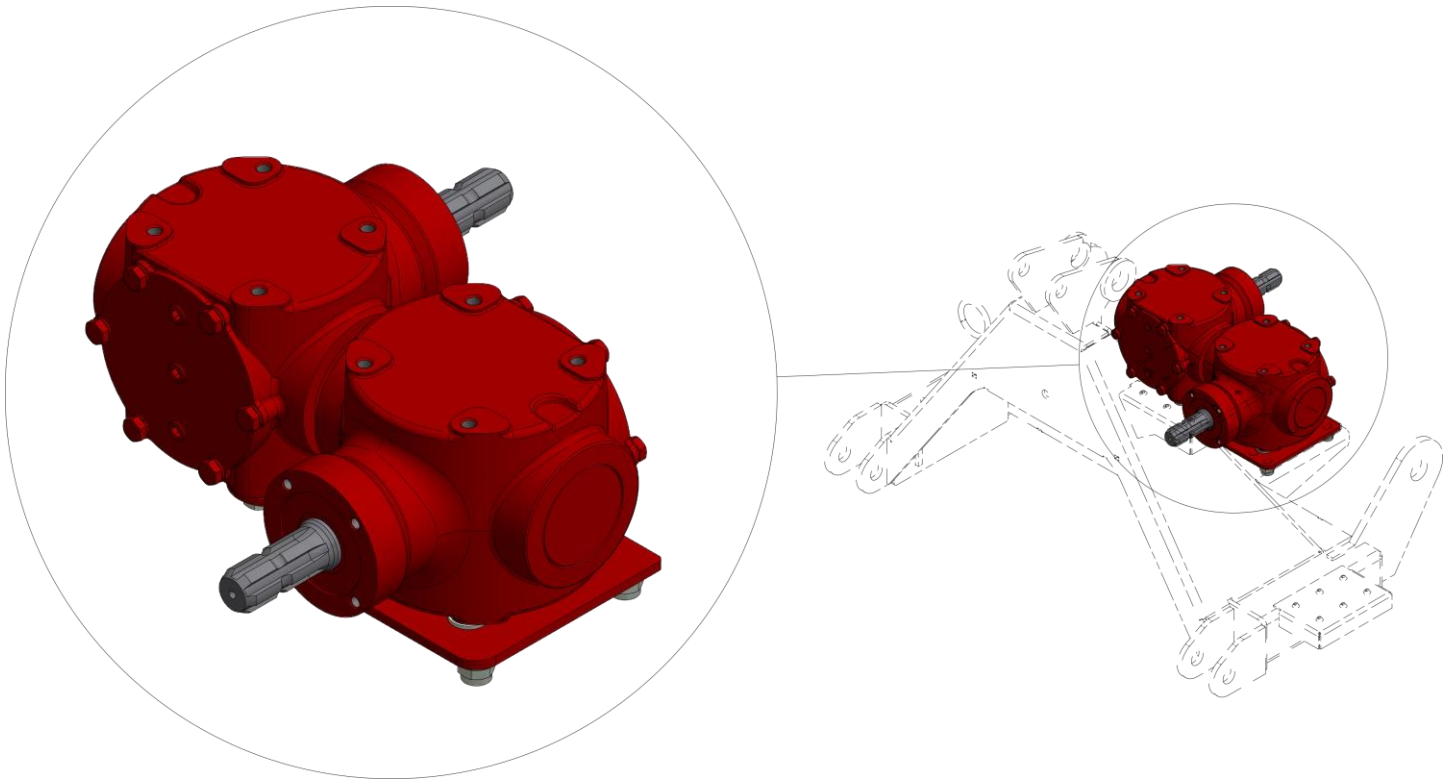
Figure 1

The double gearbox replacement. The new gearbox does not fit.

The hole pattern in the new gearbox does not match the hole pattern on the tractor attachment.

The plate (position 7) is an adapter plate to adapt the hole pattern on the new gearbox to the hole pattern on the pump mount.

Follow the instructions below before the replacement to a new gearbox.
