# Service description

Product: SP200	Service description no: 3112-S014	Ver: 1
-------------------	---	-----------

Gearbox change 90°.

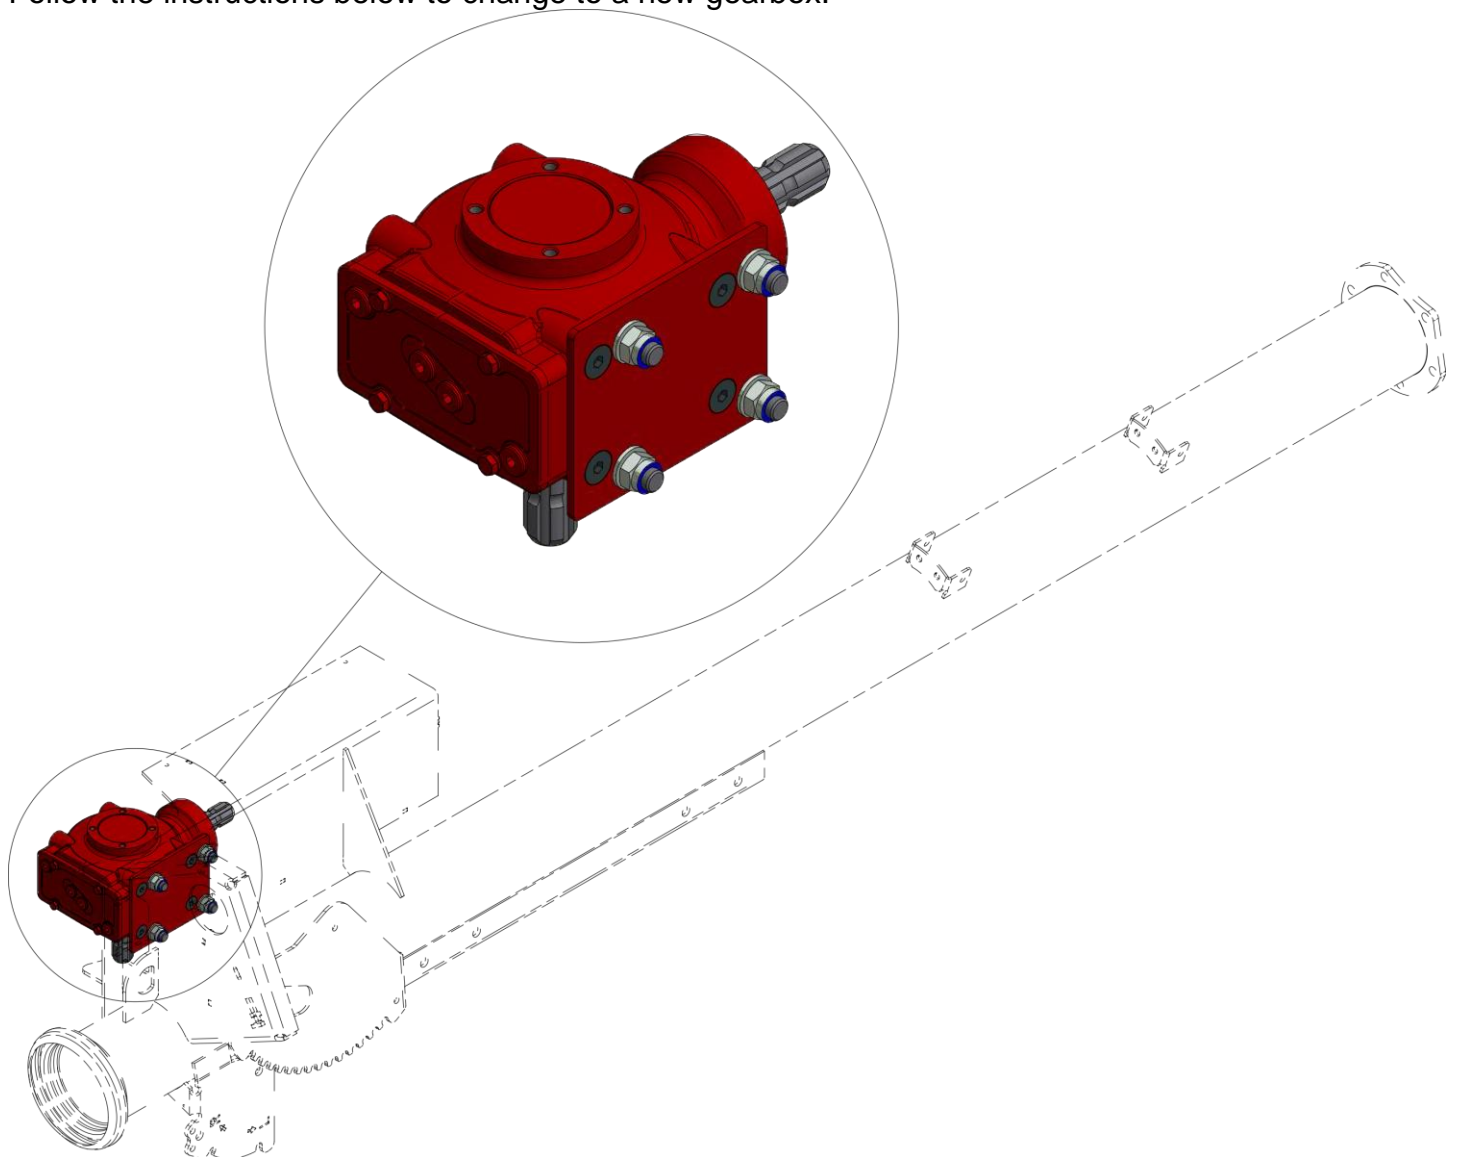
Figure 1

The hole pattern of new a gearbox does not match the hole pattern on a pump stem.

Follow the instructions below to change to a new gearbox.
