Service description

Product:	Service description	Ver:
	no:	
SP400	3125-S006	1

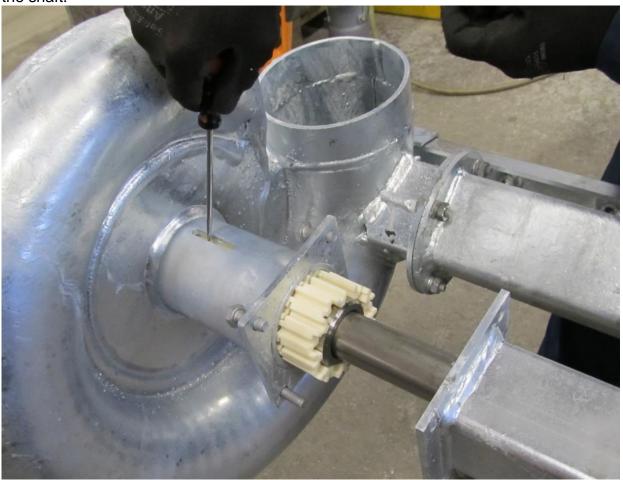
The pump has been used a lot and the plastic bearings worn out.

Use a screwdriver or something similar and push out the four plastic bearings. Remove them from the shaft.

Put on four new plastic bearings. Bearings have an opening that they could be placed around the shaft. Assemble the pump by following instructions in reverse order.
