Service description

Product: SP400	Service description no: 3125-S008	Ver: 1
-------------------	---	-----------

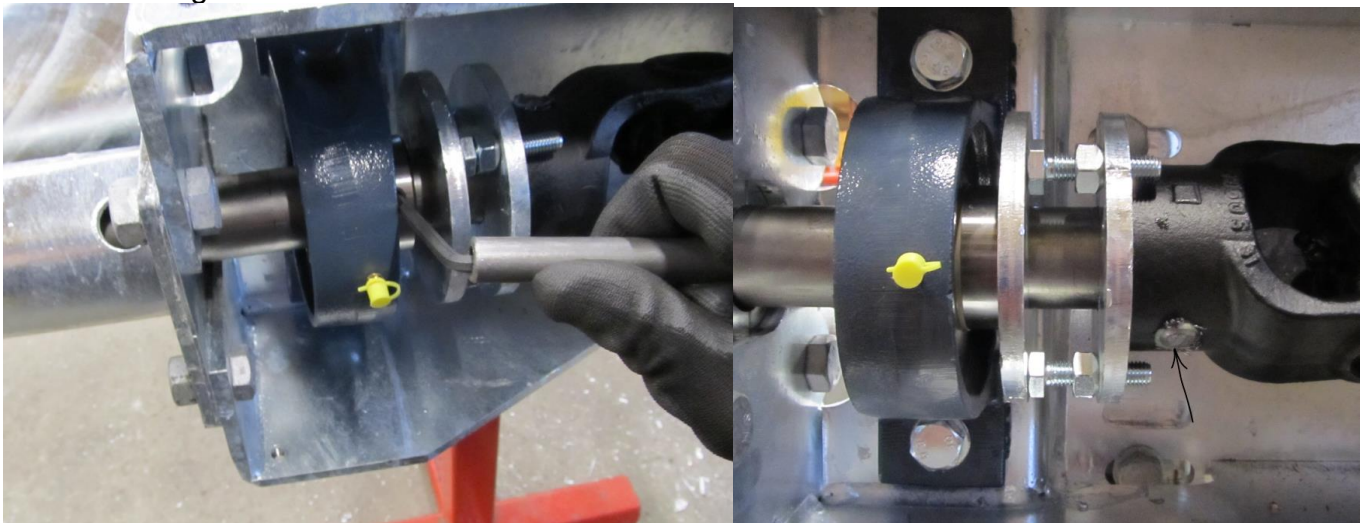
The bearing against the double joint is broken.

It may be something got stuck between the impeller and the pump housing, causing the drive shaft to be pressed down and damaging the bearing. Overlubricating the bearing can cause overheating and damage.

Push out the breaker bolt which attaches the drive shaft to the double joint. Release the set screws on the bearing.
