Service description

| Product: SP400 | Service description no: 3125-S009 | Ver: 1 |

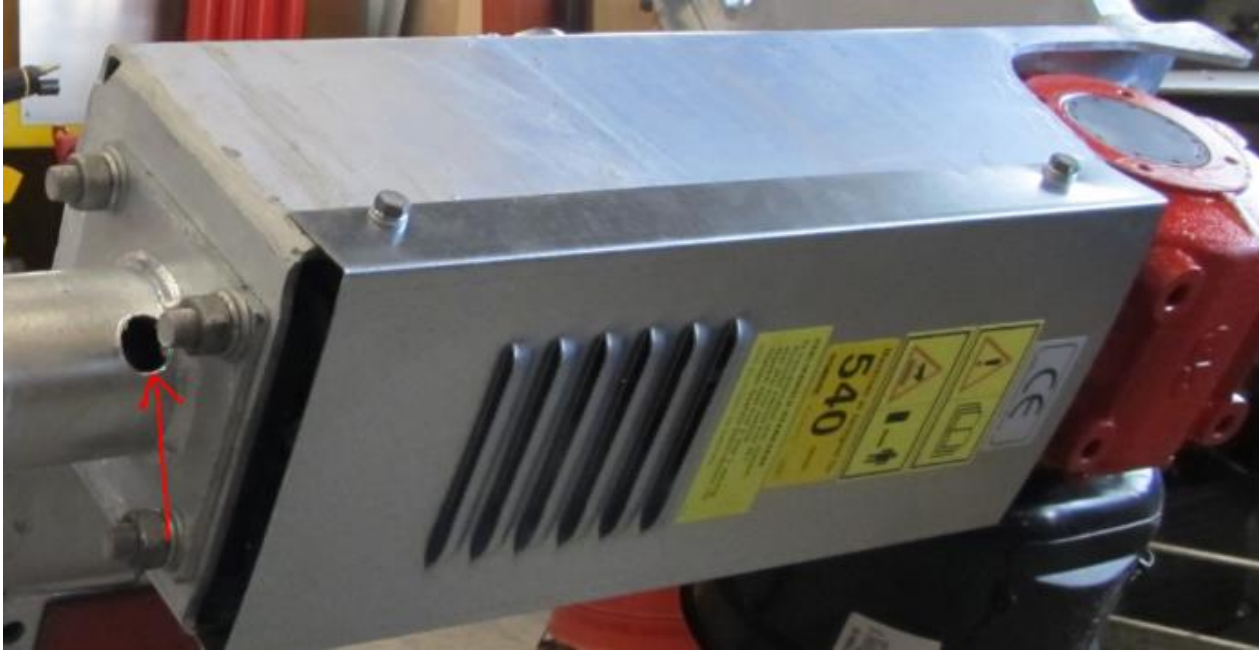
Slurry come out of the upper part of the cover tube towards the gearbox.

The drainage holes in the cover tube are blocked. The cover tube is full of slurry.
