Service description

Product: SP400	Service description no: 3125-S010	Ver: 1
-------------------	---	-----------

The double gearbox replacement.

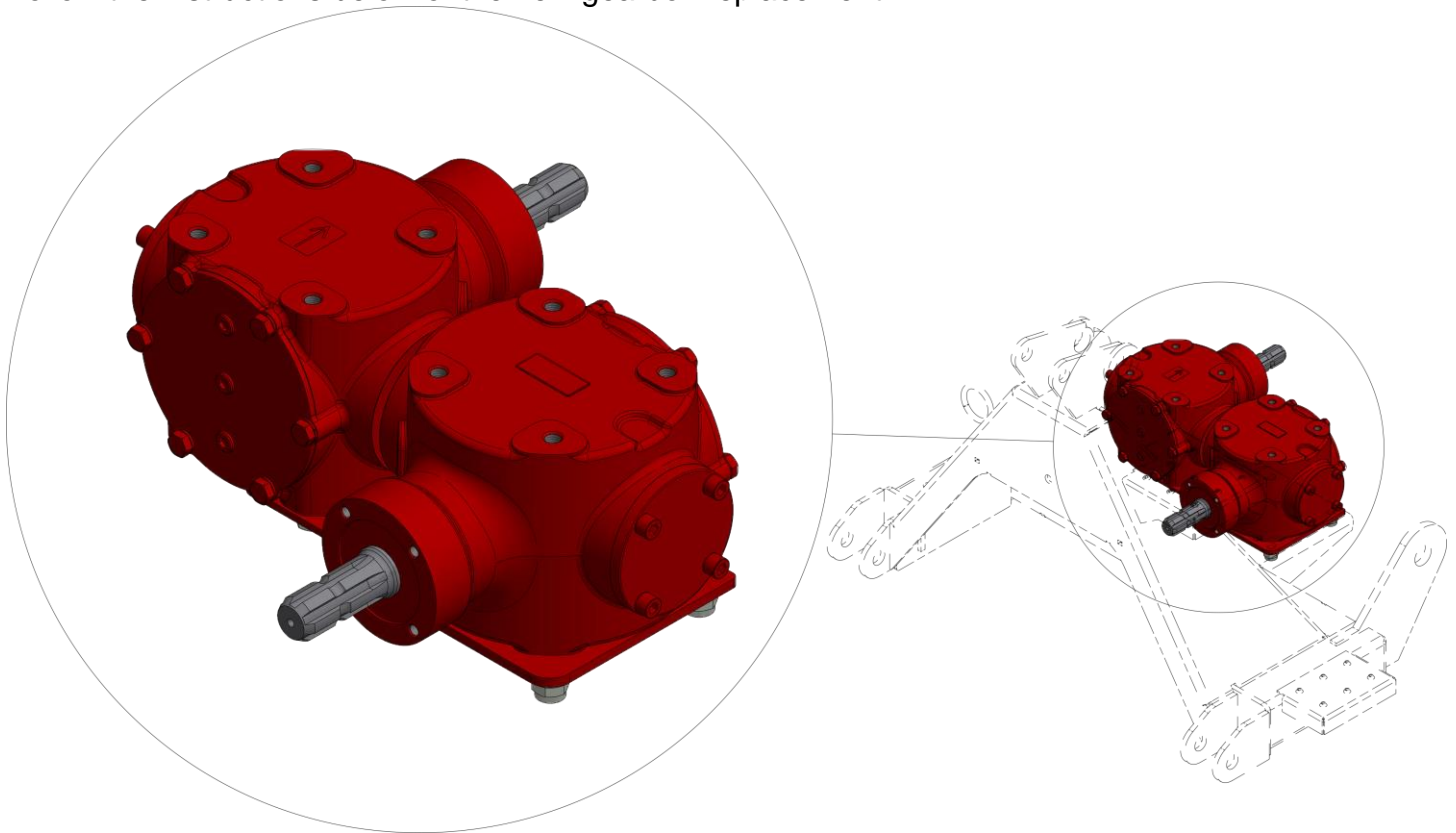
Figure 1

The hole pattern in the new gearbox does not match the hole pattern on the tractor attachment.

Follow the instructions below of the new gearbox replacement.
