Service description

Product: PA20	Service description no: 3221-S001	Ver: 1
------------------	---	-----------

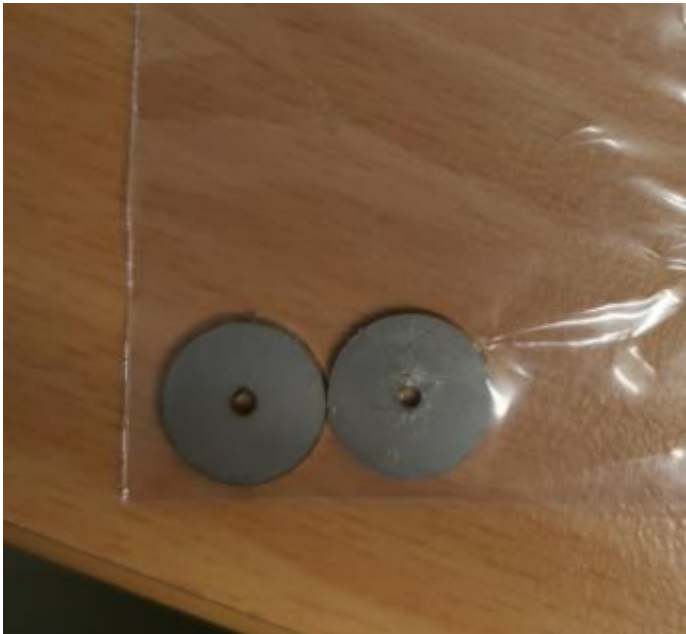
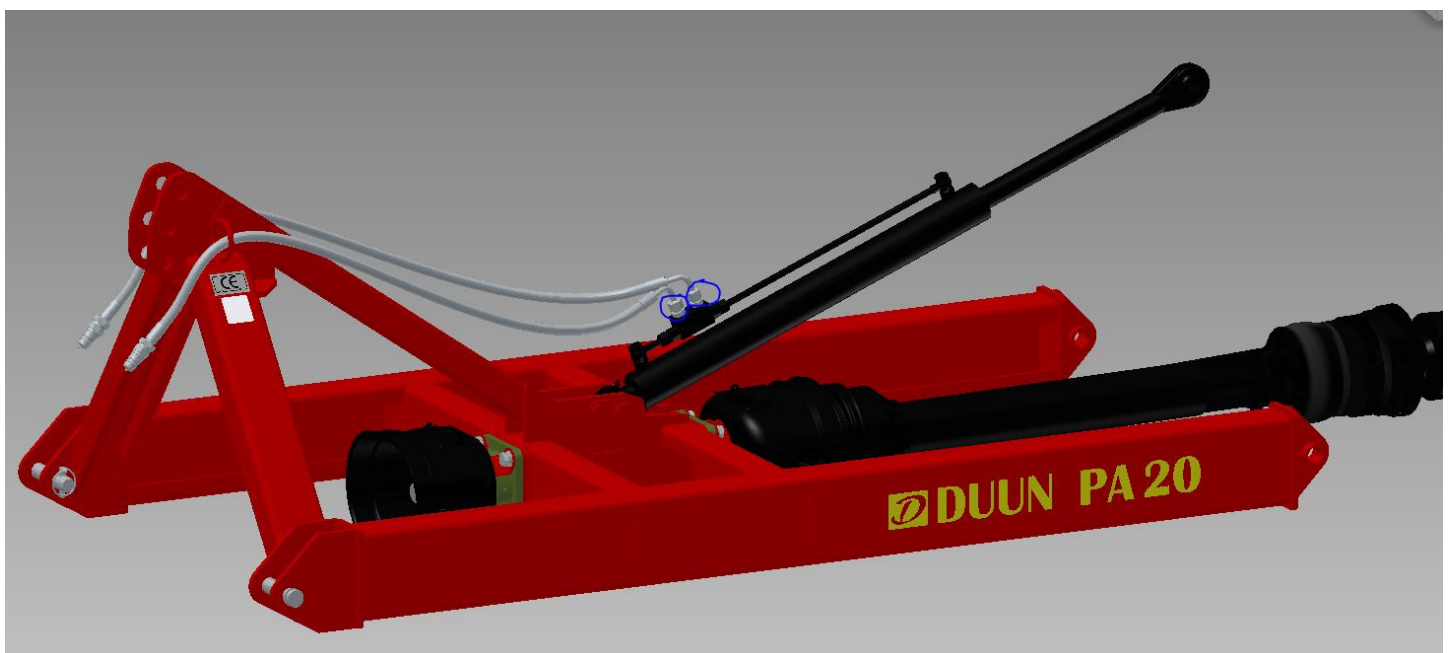
Shakes when lowering the mixer with the top strut on the PA20.

The non return valve on the top strut opens and closes.

Insert a restrictor between the hydraulic hoses and a non return valve.

Use 2 pcs. restrictors 12x1 with 1.5 mm opening. One washer per hose.
