Service description

Product: VM420	Service description No.: 4120-S008	Ver: 1
-------------------	--	-----------

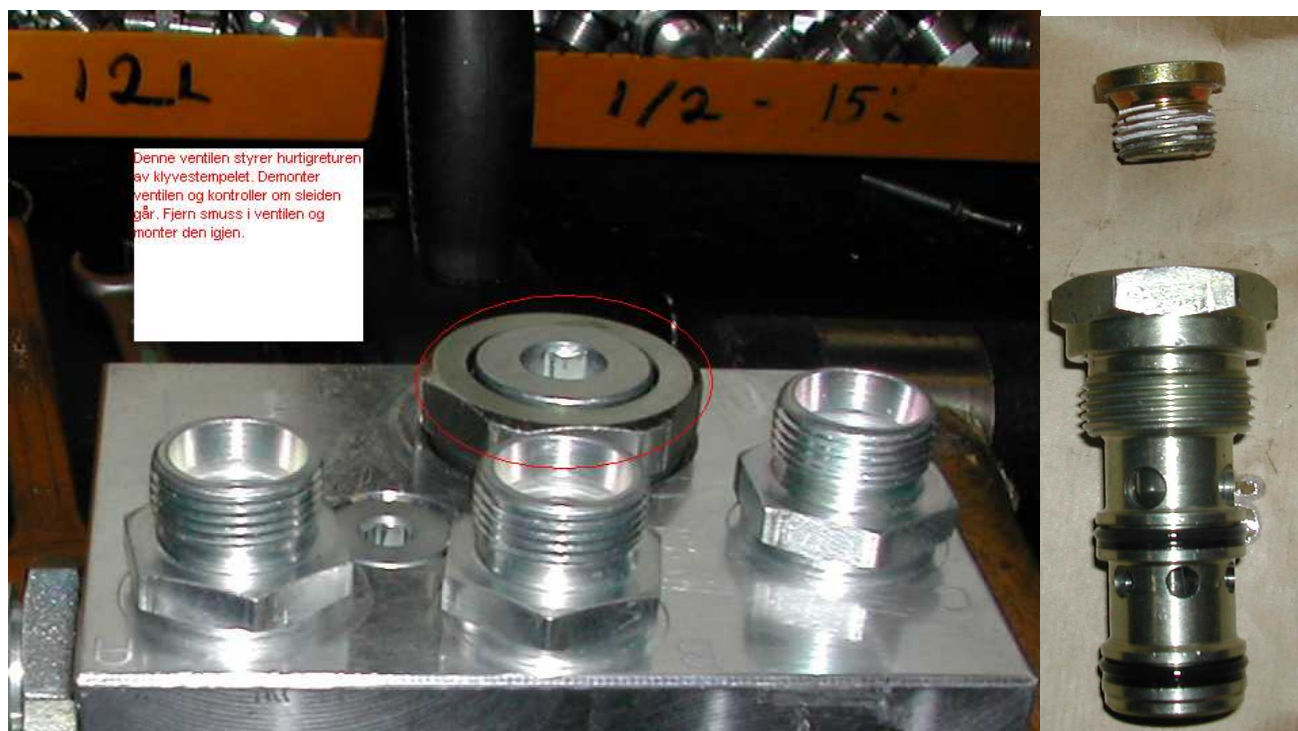
The splitting ram returns slowly.

1. Wood chips and dust clogged around the splitting mechanism and harming function.
2. The splitting mechanism being incorrectly adjusted and not allowing the valve to operate as normal.
3. The valve ensuring quick emptying of the splitting cylinder during return does not operate
4. Pressure build up at the right side and "splitting impulse" The mechanism does not manage to operate.

1. Dismount the cover in front of the mechanism. Take care of moving parts at high pressure!! Remove wood chips and similar material causing dysfunction.
2. Watch [4120-S004](#)
3. Dismount the valve ensuring quick emptying of the splitting cylinder during return and ensure that the valve plunger can be operated manually by compressing the valve plunger with a blunt object not causing groves. If the valve plunger is stuck it must be dismounted (watch picture).
4. Watch [4120-S009](#)

The valve looks like this. Dismount the plug, pick out spring and plunger and remove eventual contaminants. Assemble the parts and apply thread tape as illustrated.
