Service description

Product: VM420	Service description No. 4120-S013	Ver: 1
-------------------	---	-----------

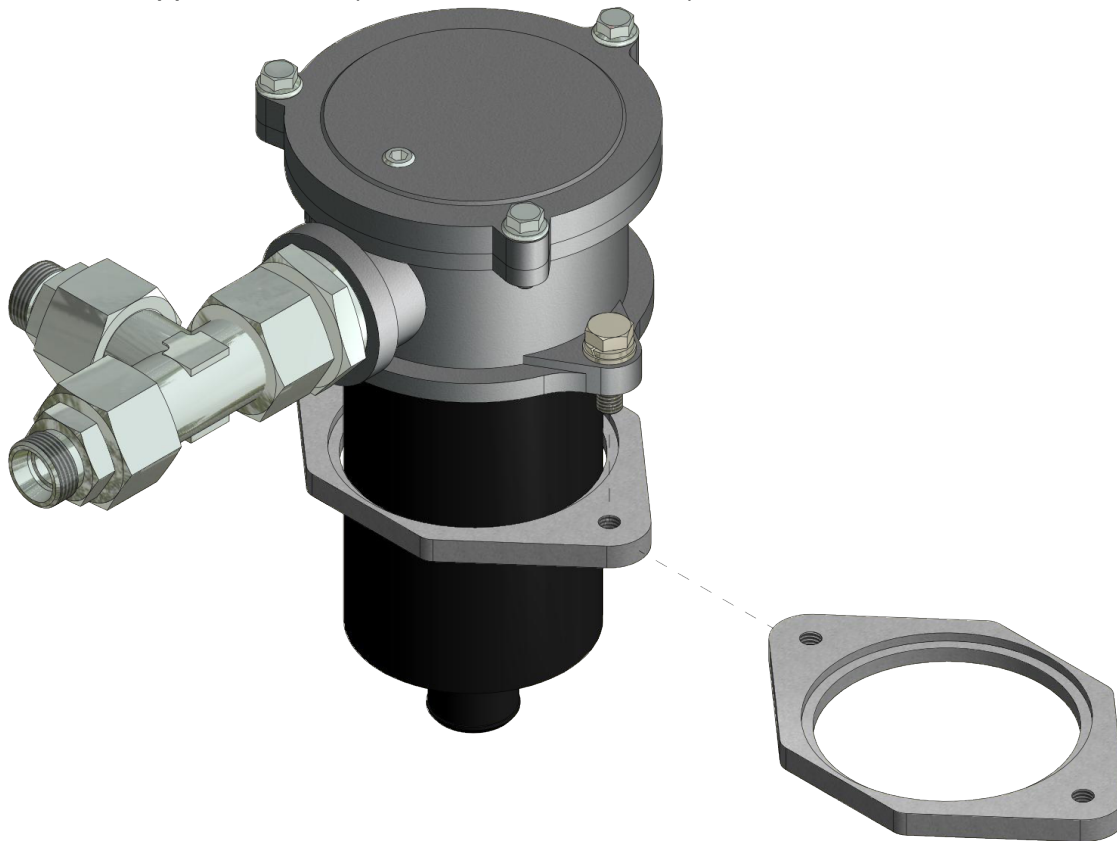
Leakage in filler cap for hydraulic oil tank.

The return filter being directly attached to the tank. Vibrations during use might cause leakages around the filler cap.

Mount a support washer (our item No, 14120274) at the inside of the oil tank.

1. Dismount filtering unit
2. Loosen the filter housing
3. Dismount the two 8 millimeter thread inserts fixed to the sheet.
 - Apply the fastening screws for the filter to avoid thread inserts from falling into the tank.
4. Position the support washer downside the aluminium sheet and fasten the filter unit.
