Service description

| Product: VM420 | Service description No.: 4120-S015 | Ver: 1 |

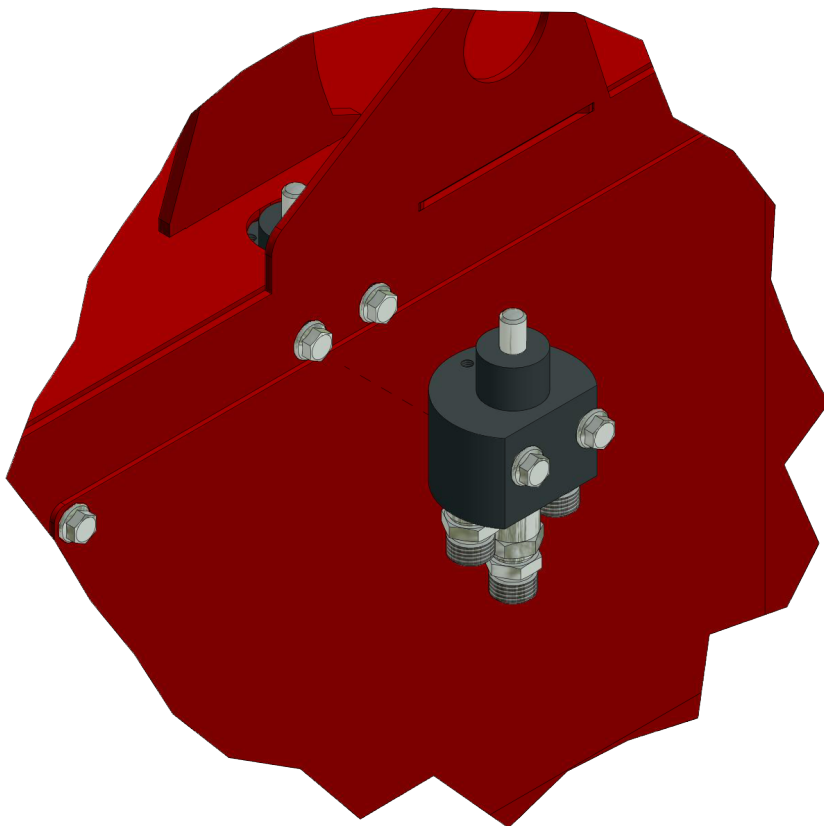
No effect from joy stick movement

The safety valve for the cover above splitting ram is incorrectly adjusted or does not function properly.

- Open protection cover above tray for the splitting ram
- Unfasten screws fastening the valve with a sixe 10 key and push the valve upwards till stop position.
- Tighten screws lightly.
- Close protection cover above tray and check that the valve plunger is compresses and that the valve slides downwards till it stops in correct position when the lid is completely closed.
- Tighten screws.
