Service description

Product: VM420	Service description No.: 4120-S018	Ver: 1
-------------------	------------------------------------------	-----------

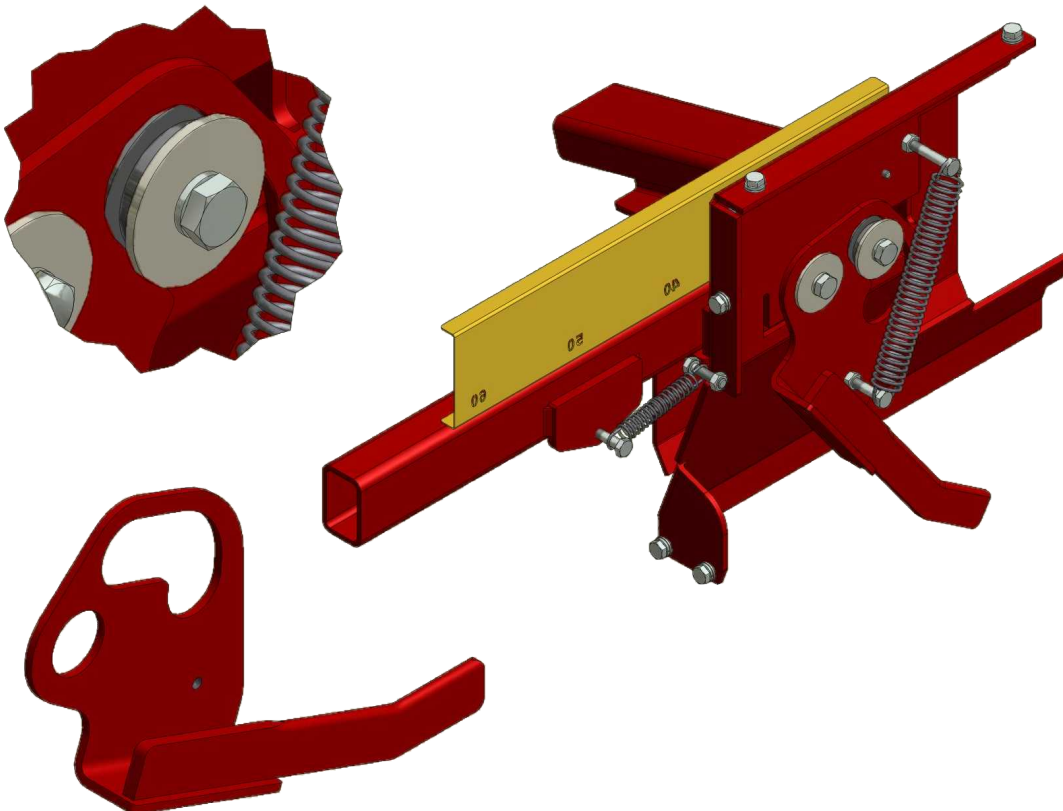
1. Chips surround the "log stopper" and reduces the movement.
2. Build up of saw chips in the guide groove for "log stopper".
 - Valid for serial no from. 09001 to and including 09085
3. Too much friction between "glide surfaces" that is tube caging the log stopper and the surfaces of the bracket..
4. The hydraulic hose connecting the saw movement cylinder is mounted in incorrect angle
5. Internal leakage in saw cylinder.
6. The saw bar do not move vertically down, but slanted causing the bar to jam.
7. Grooves in the saw bar and blunt saw chain

1. Clean the "log stopper" surroundings.
2. Replace bracket 14120070 with new version having a prolonged groove.
3. Lubricate glide surfaces..
