Service description

Product: VM450	Service description no: 4121-S001	Ver: 1
-------------------	---	-----------

Leakage on the block under the oil tank. Regenerative block.

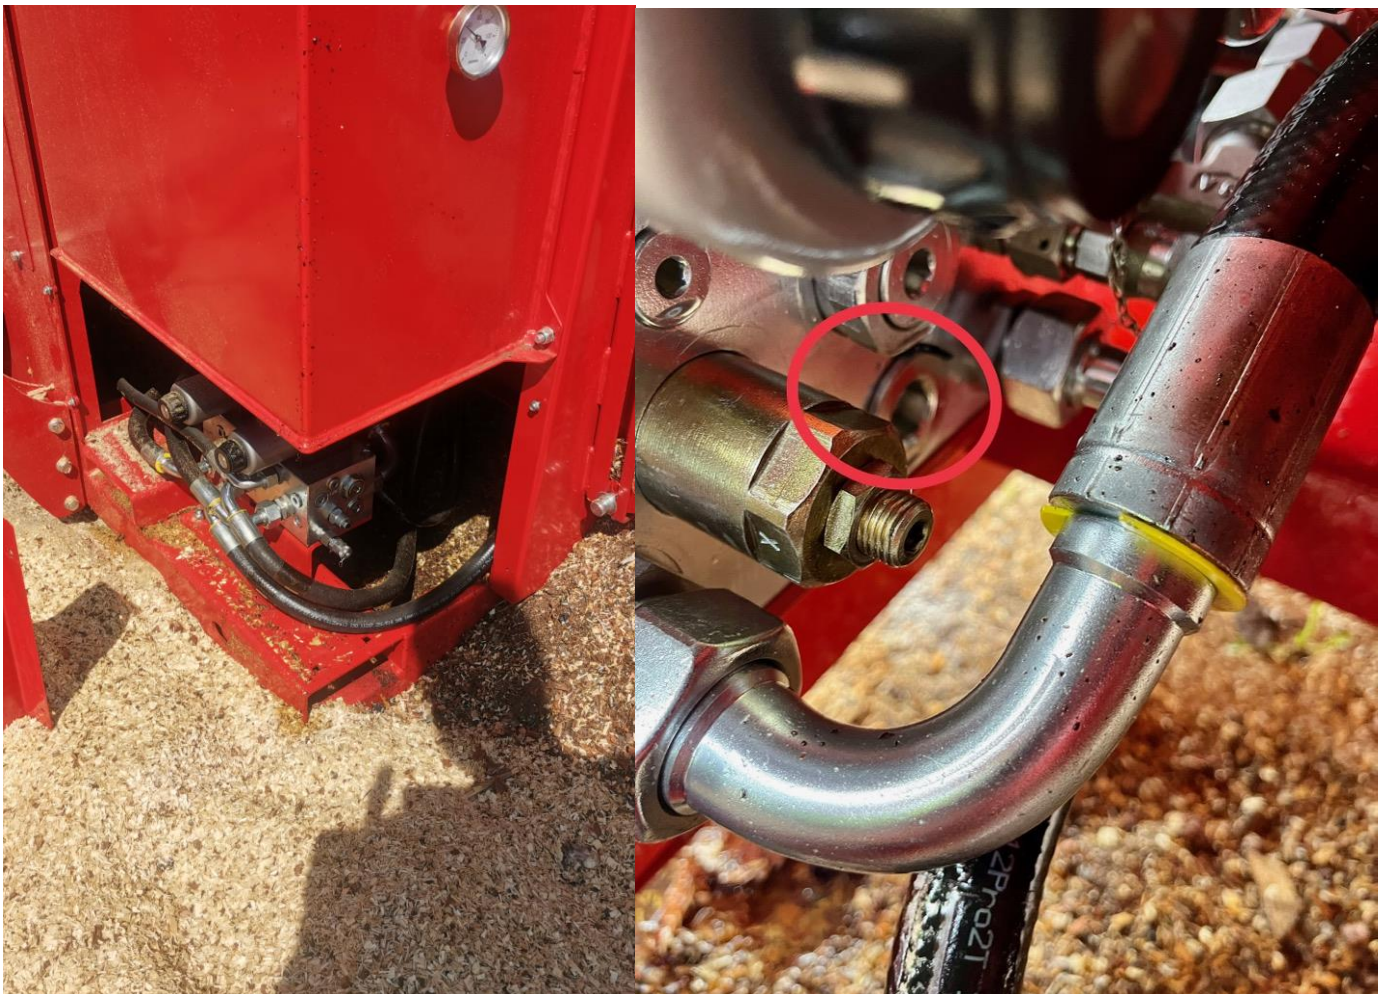
The O-ring is blown out because the plug in the block is too long and the threads go down before the O-ring is compressed.

Put in a new plug.
