Service description

Product: VM370	Service description no: 4131-S004	Ver: 1
-------------------	---	-----------

Leakage from hydraulic block 2955419

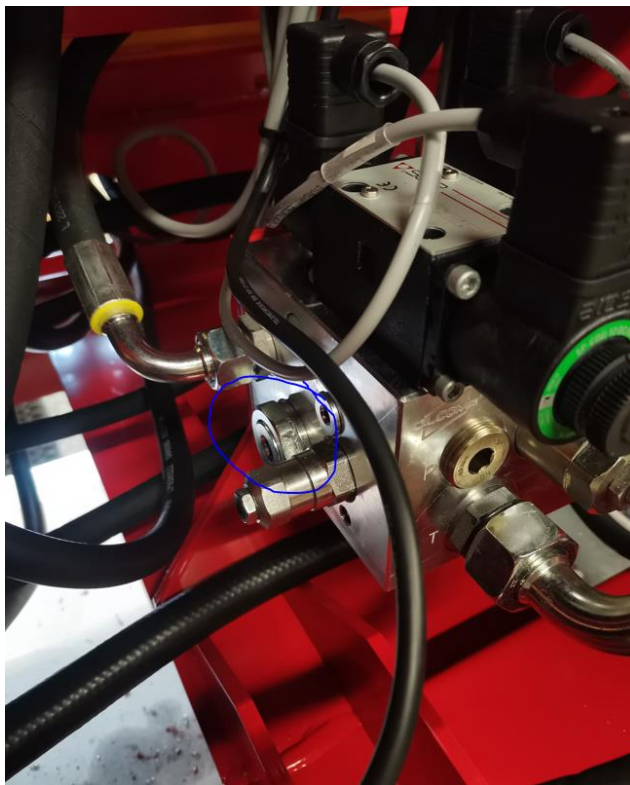
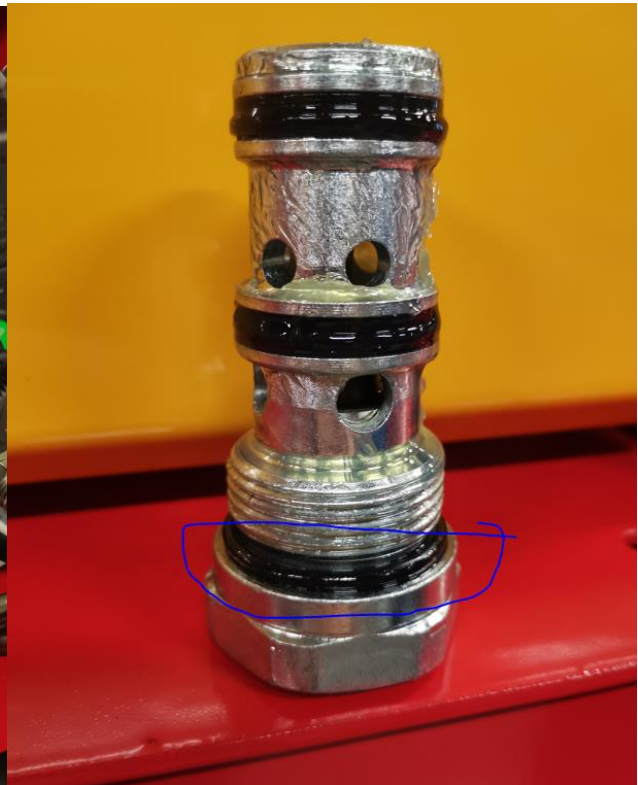
O-ring is not tight and must be replaced.

Release the hexagon on the plug and insert a new O-ring. 2233028 O-ring 28,2 X 3,0 70NBR
Estimated time consumption is 30 min.
