Service description

Product: VM320	Service description no: 4132-S001	Ver: 1
-------------------	---	-----------

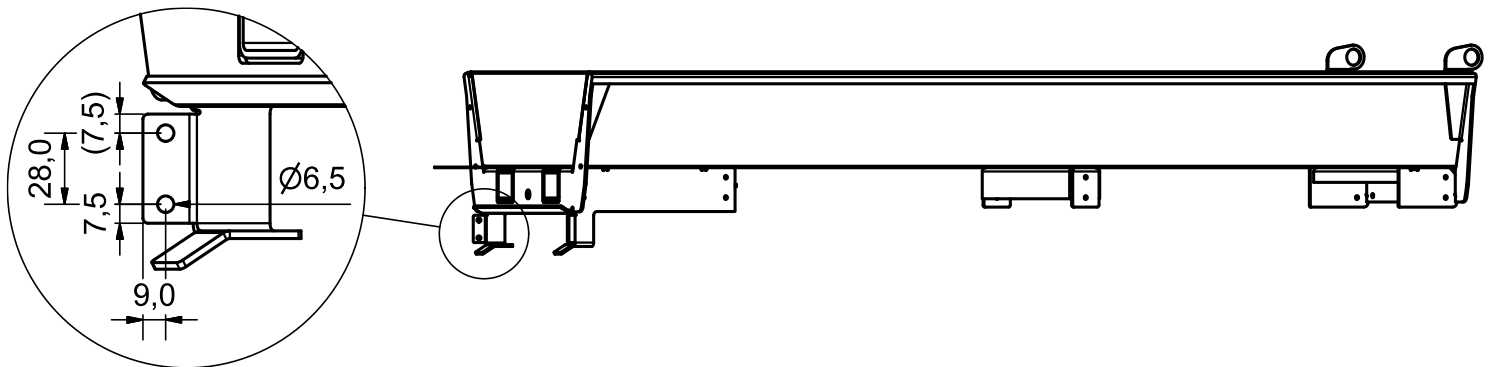
The carriers on the conveyor belt hook into the inlet of the conveyor belt.

The carriers are rotated more than the inlet can tolerate.

Drill four Ø6.5 holes, as shown in the picture above.
