## Service description

Product: ST2440	Service description no: 4140-S001	Ver: 1
--------------------	---	-----------

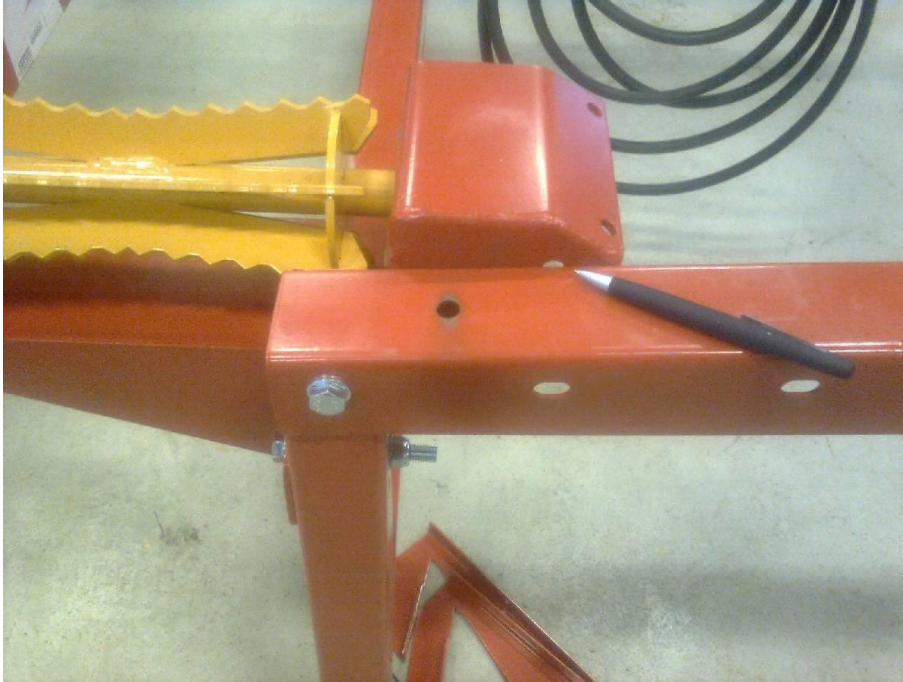
Figure 1

Screw holes on the bracket 14140021 and 14140022 do not fit against lap bank 14140033. (Figure 1)

1. Manufacturing defects on the racks produced between 30.08.2011 and 01.12.2011

1. Mark and drill a new hole  $\text{Ø}13$ . (Figure 2)
