# Service description

Product: VM420	Service description No.: 4120-S009	Ver: 1
-------------------	--	-----------

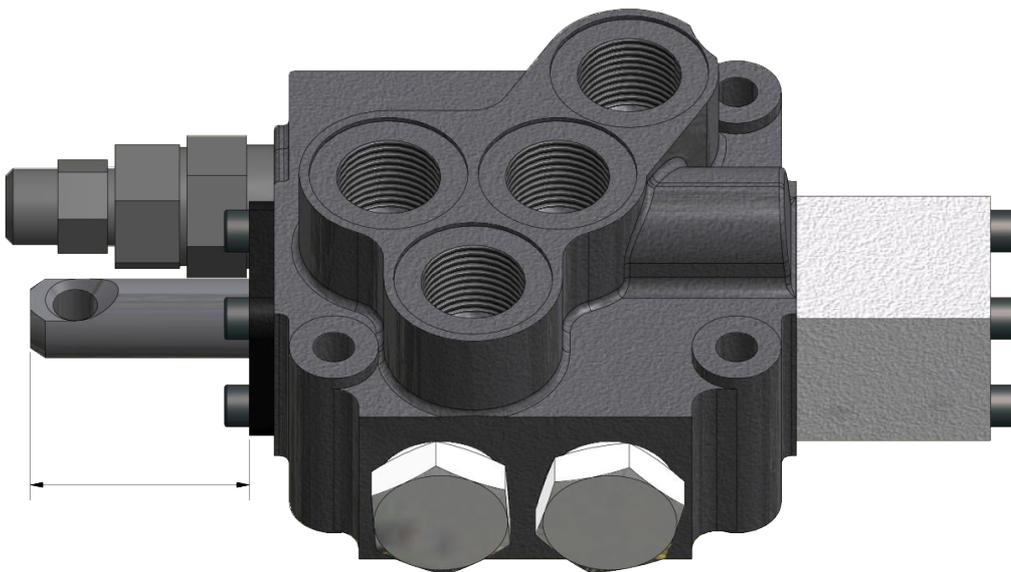
The splitting ram does not start.  
The splitting ram works continuously.  
The splitting ram creeps out.

1. Wood chips and dust in the splitting mechanism
2. Incorrectly adjusted valve for splitting mechanism
3. Internal leakage in valve for splitting mechanism

1. Stop tractor engine
  - Open lid in front of mechanism
  - Remove chips and dust around mechanism.
  - Start tractor / engine and test the splitting function
2. Watch [4120-S004](#)
3. Remove lid at the right side of the splitting valve and check the plunger for oil going through the valve. If the leakage is substantial the O-ring 17,12x2,62 NBR must be replaced.
