Service description

Product: SP200	Service description no: 3112-S002	Ver: 1
-------------------	---	-----------

Adjusting the distance between the impeller and cutter.

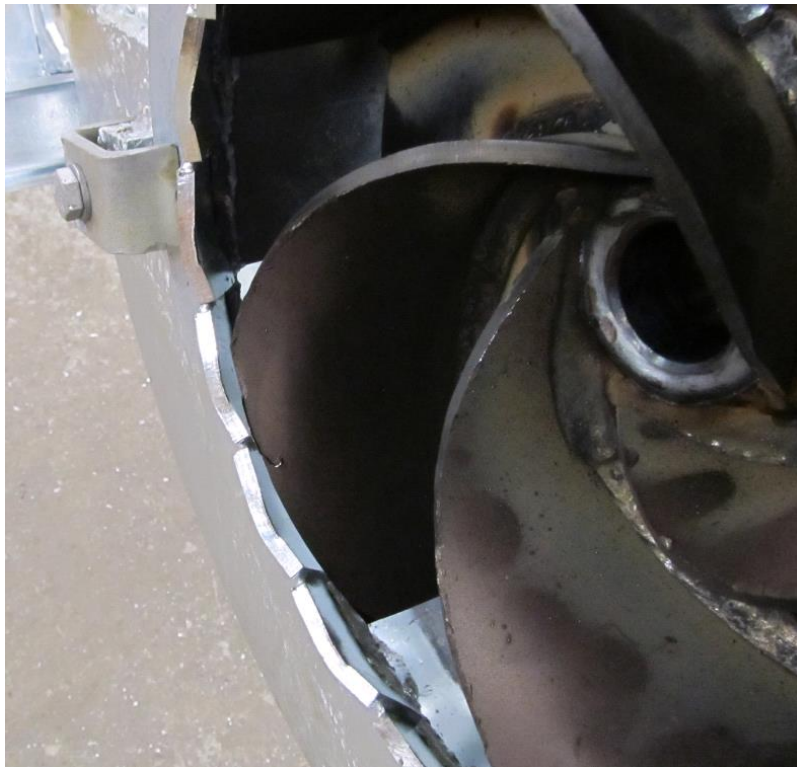
In order to maintain good cutting productivity, distance between the impeller and the cutter should be 2-3 mm. The distance is checked at least once per season or after 40 hours. If the distance is too small, an impact may occur, causing vibration. Too large distance will cause loss of power.

Adjust the distance between the impeller and the cutter.

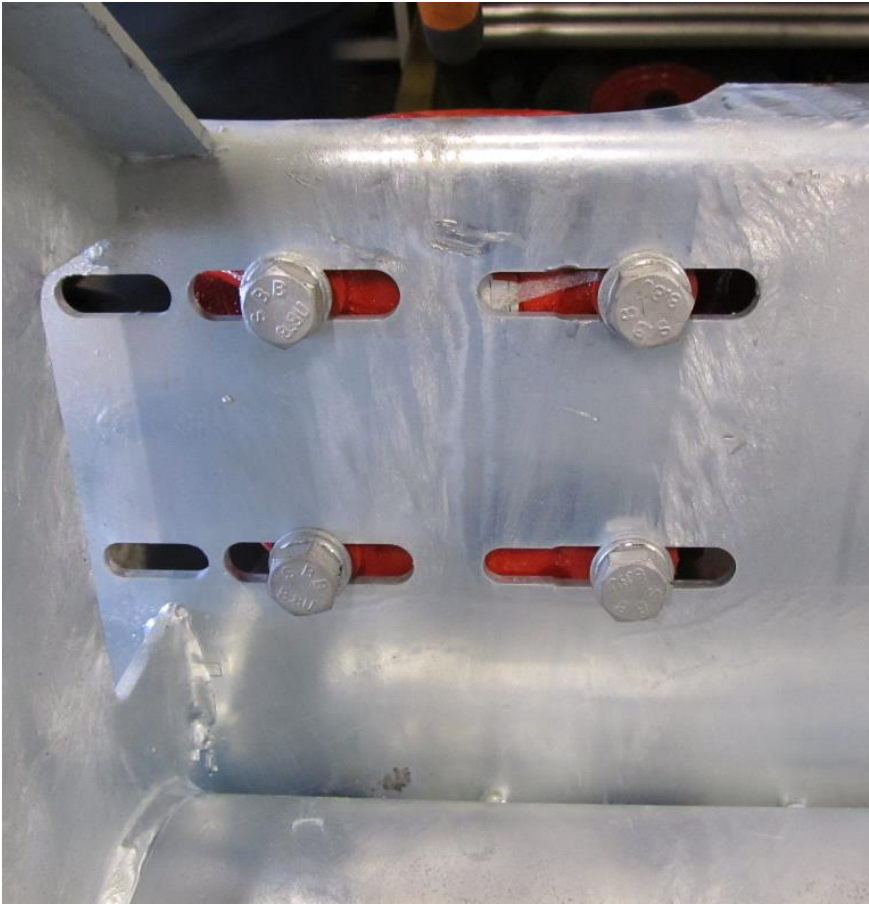
1. Loosen up the screws such as the gearbox.

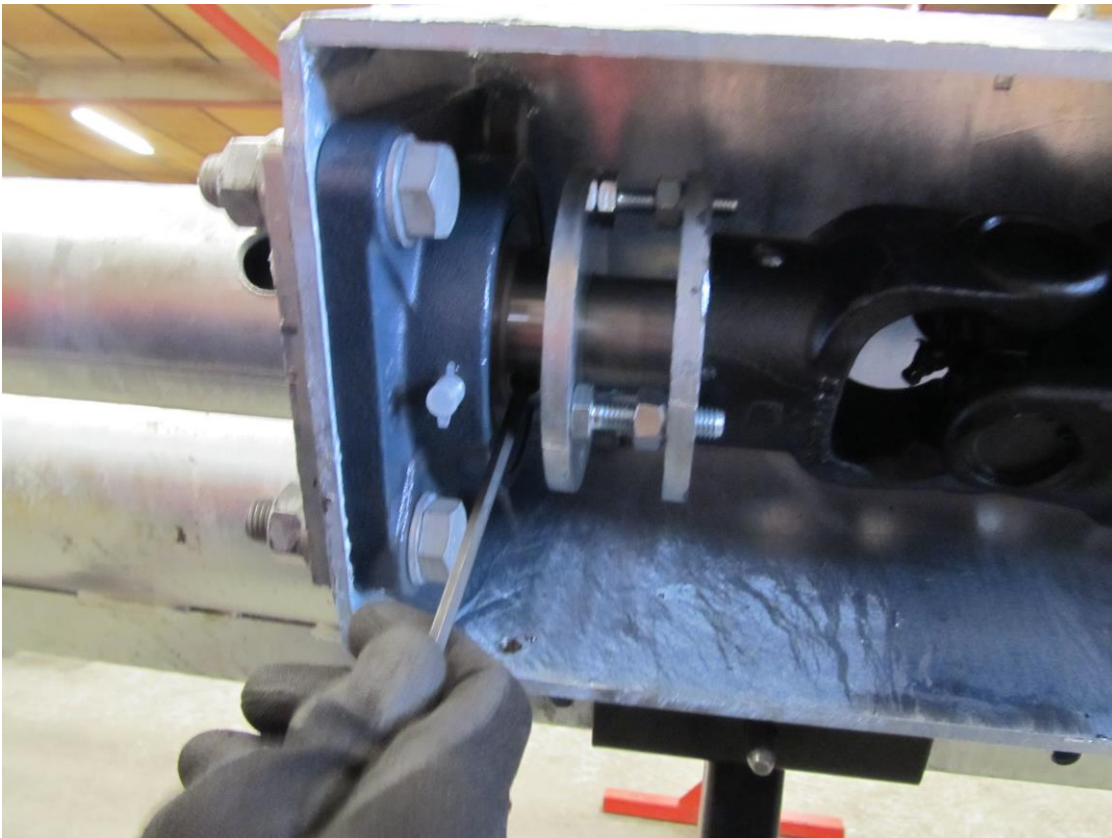
2. Loosen up the set screw on the bearing.

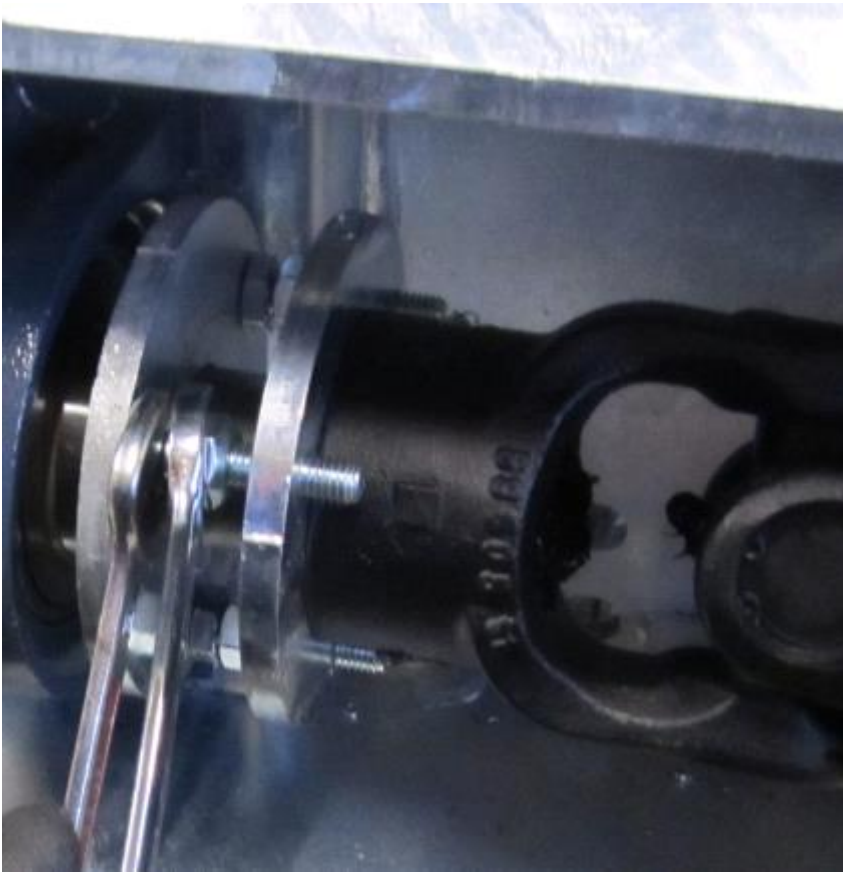
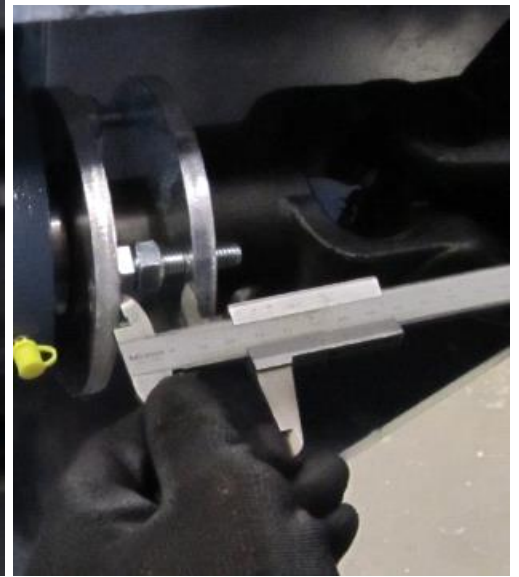
3. Adjust the distance in the pump housing by adjusting the distance washers between the bearing and the universal joint. By reducing the distance between washers, the universal joint will be moved down towards the bearing and the distance between the impeller and the cutter will decrease. It is important to check if the distance between three adjustment screws is the same.
