# Service description

Product: SP200	Service description no: 3112-S003	Ver: 1
-------------------	---	-----------

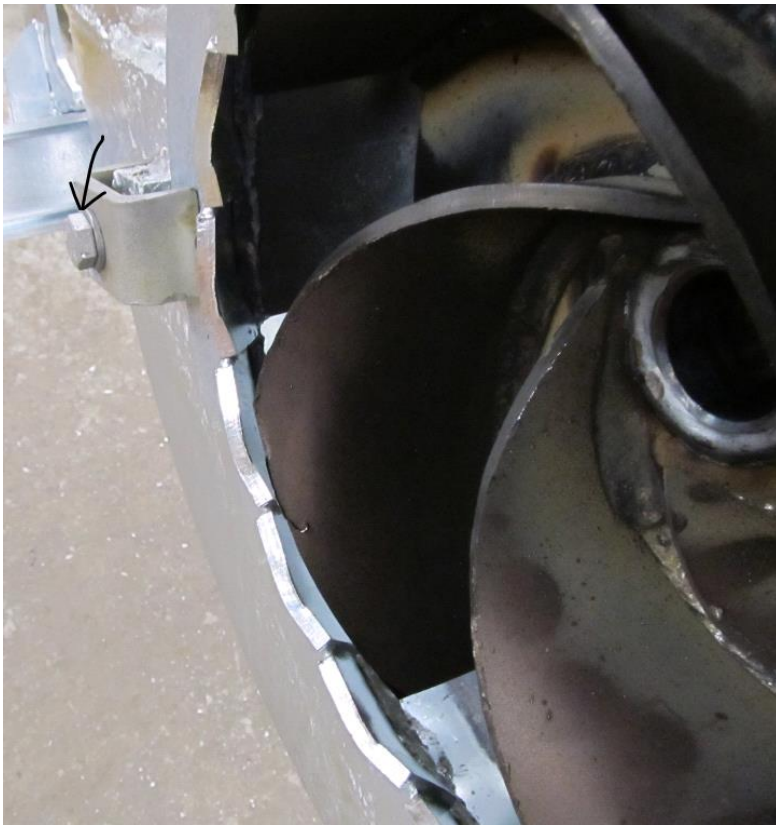
Release four screws that hold the cutter.

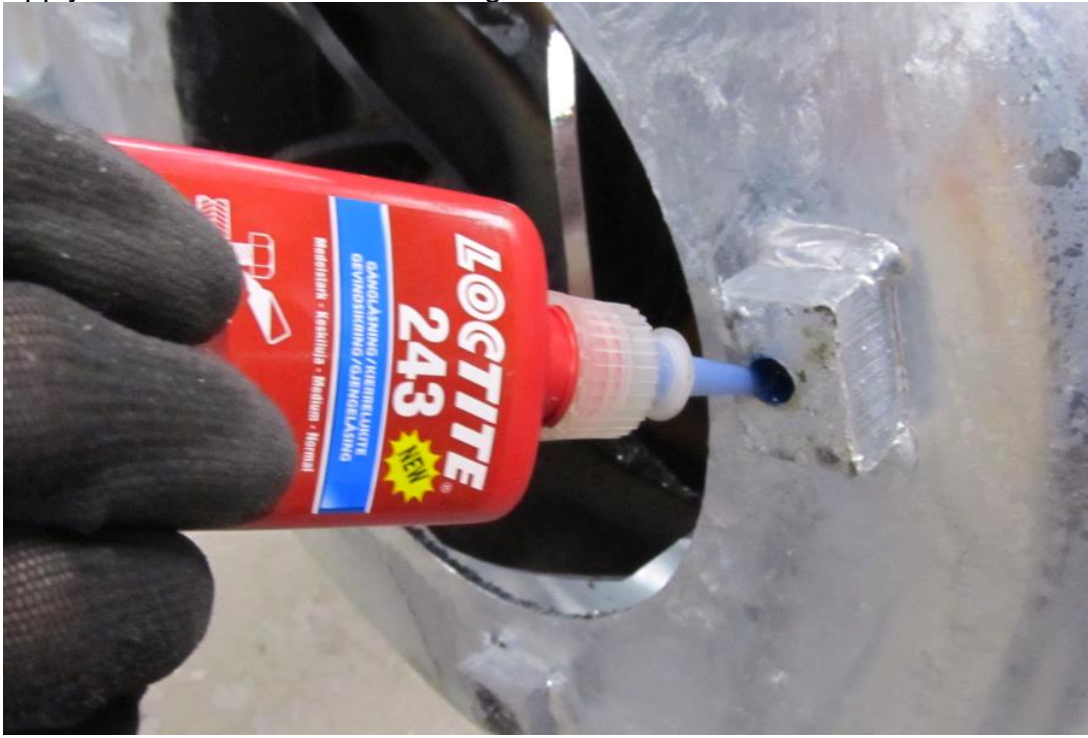
Apply Loctite and attach a new ring.
