Service description

| Product: SP200 | Service description no: 3112-S004 | Ver: 1 |

Replacement of impeller.

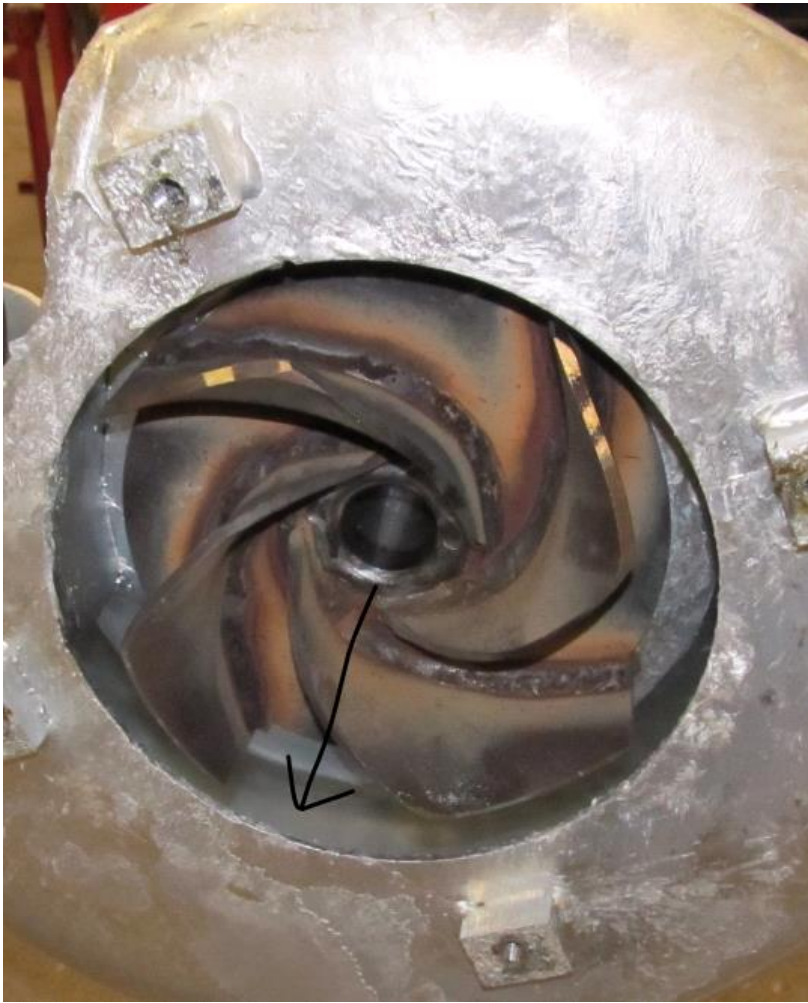
Remove the cutter from the pump housing and pull the impeller out of the pump housing.

Replace the impeller and assemble the pump by following the instructions in reverse order.
