## **Service description**

Product:	Service description	Ver:
	no:	
SP200	3112-S011	1

The double gearbox is damaged or defective.

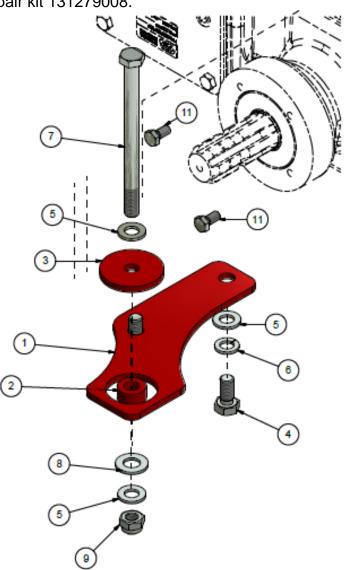
Pos	No	Article no	Designation
1	1	13127033	Gearbox support
2	1	13127034	Spacer sleeve f/gearbox support
3	1	13127035	Washer f/gearbox support
4	2	2422346	Hexagon screw M12x25 EIZn 8.8 DIN 933
5	4	2531069	Washer M12 EIZn DIN 125
6	2	2534069	Spring washer M12 EIZn DIN 127
7	1	2422370	Hexagon screw M12x160 EIZn 8.8 DIN 931
8	1	2531072	Washer M14 EIZn DIN 125
9	1	2483611	Locking Nut M12 ELZn DIN 985
11	2	2422240	Hexagon screw M8x16 EIZn 8.8 DIN 933

Replace the mounting bracket with a repair kit which ensures the gearbox mounting can move. Repair kit 131279008.
