Service description

Product: SP400	Service description no: 3125-S002	Ver: 1
-------------------	---	-----------

Adjust distance between the impeller and the cutter.

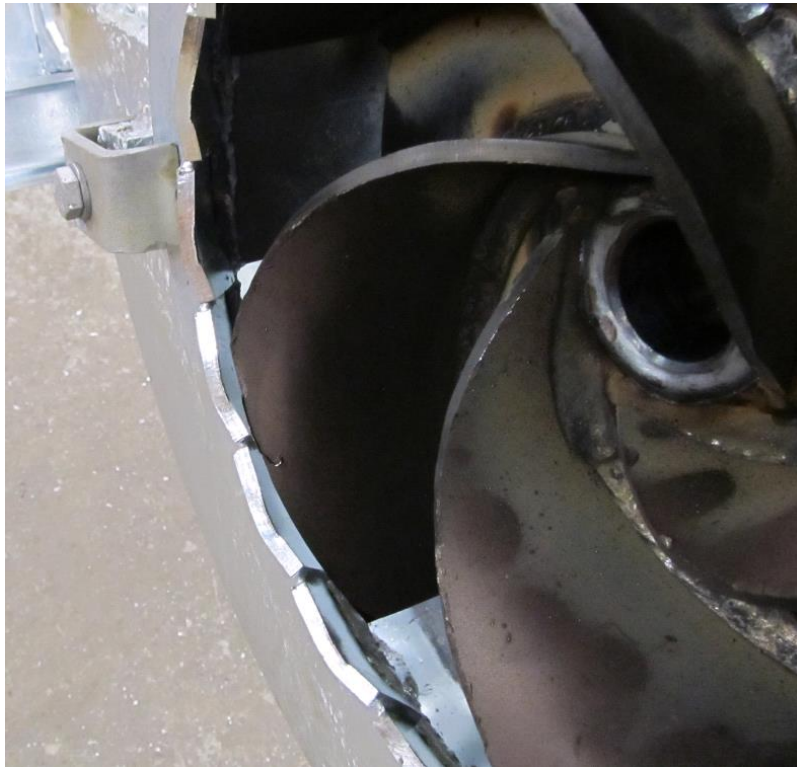
To maintain good cutting capacity, the distance between the impeller and the cutter must be 2-3mm. The distance is checked at least once per season or after 40 hours. If the distance is too small, a bump may occur which causes vibrations. Too large distance will result in a loss of power.

Adjust the distance between the impeller and the cutter.

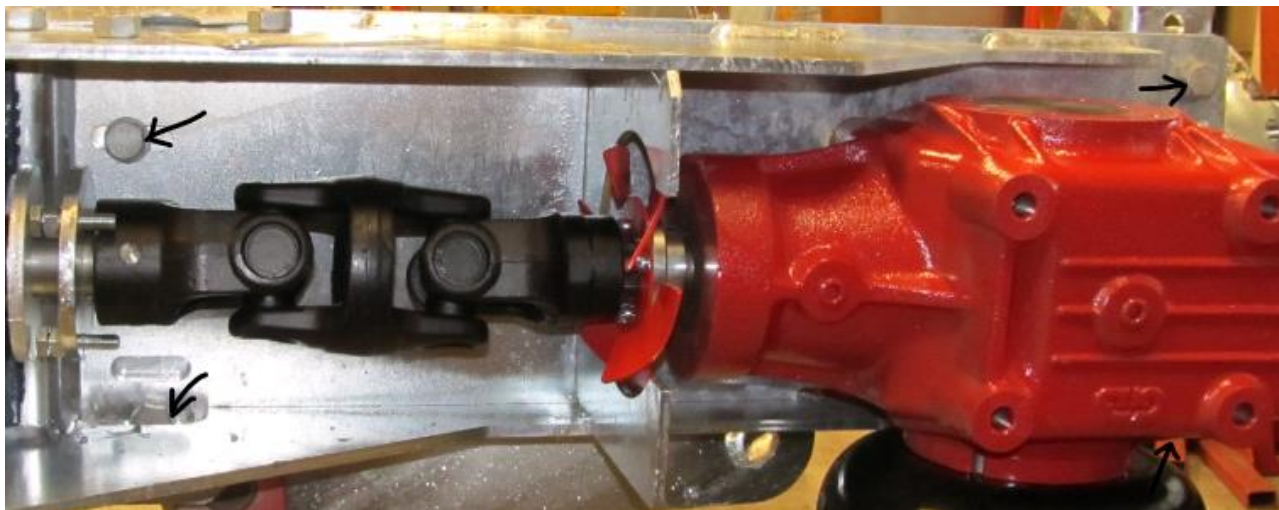
1. Release the screws that hold the housing, where the gearbox is located.

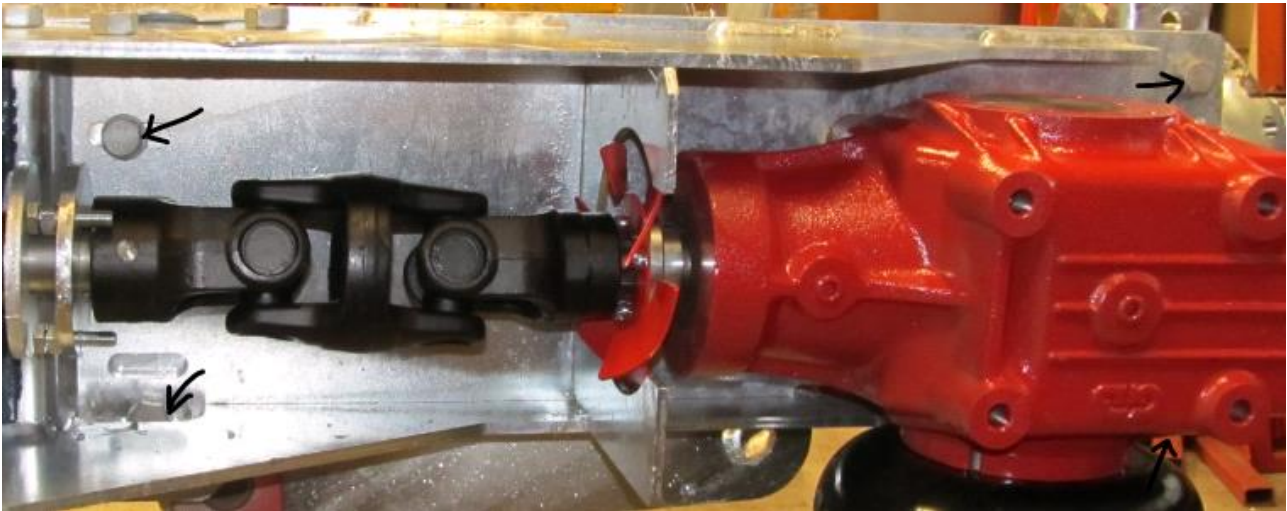
1. Release the screws that hold the housing where the gearbox is located.

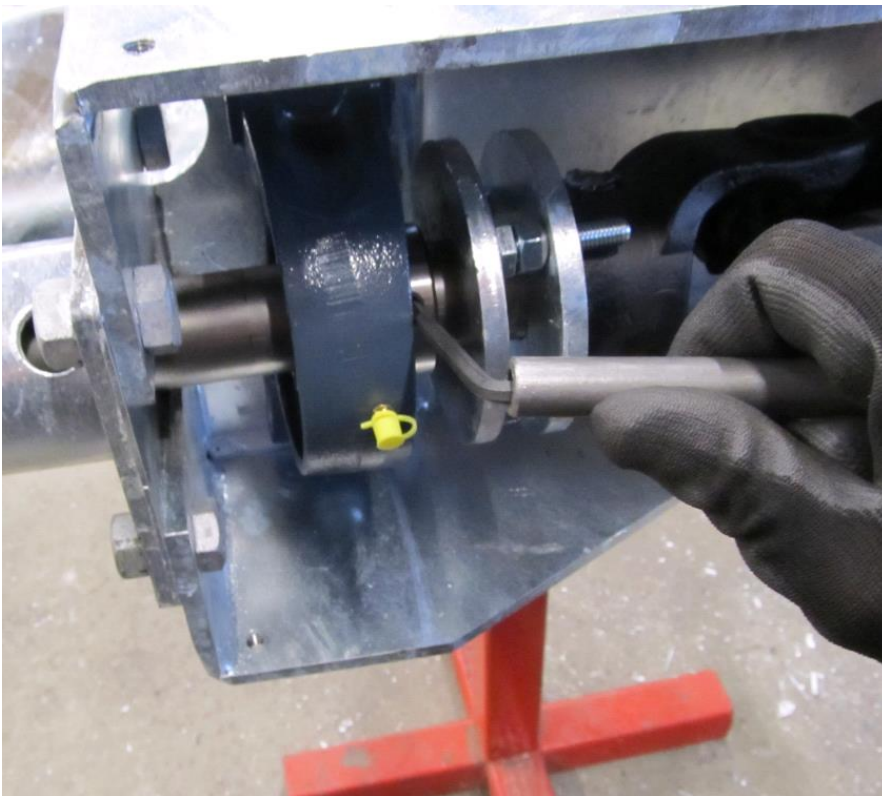
3. Release the set screws on the bearing.
