Service description

Product: SP400	Service description no: 3125-S003	Ver: 1
-------------------	---	-----------

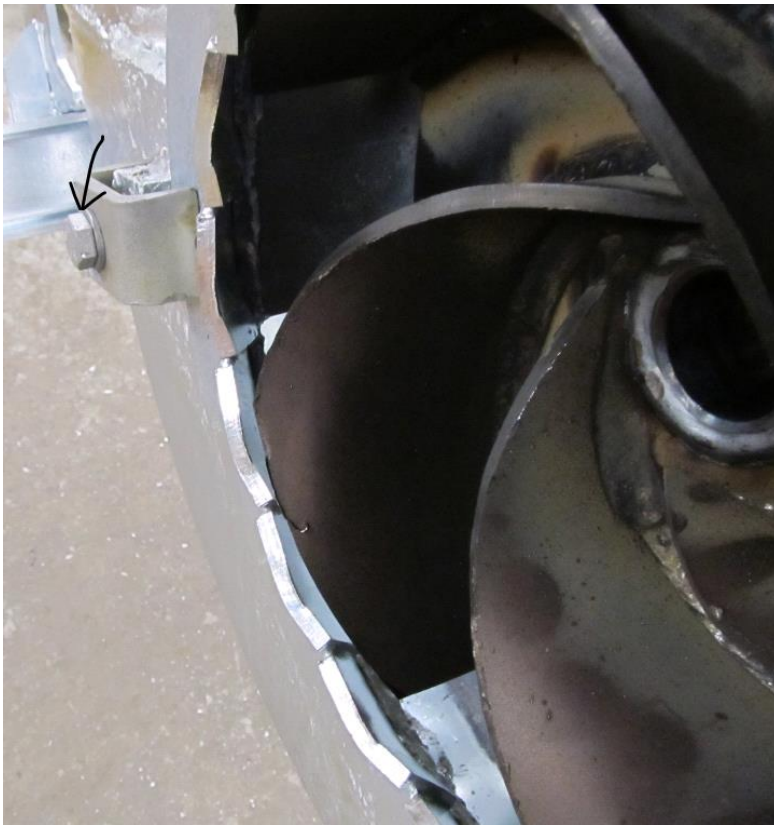
Release the four screws that hold the cutter.

Replace the cutter with a new one.

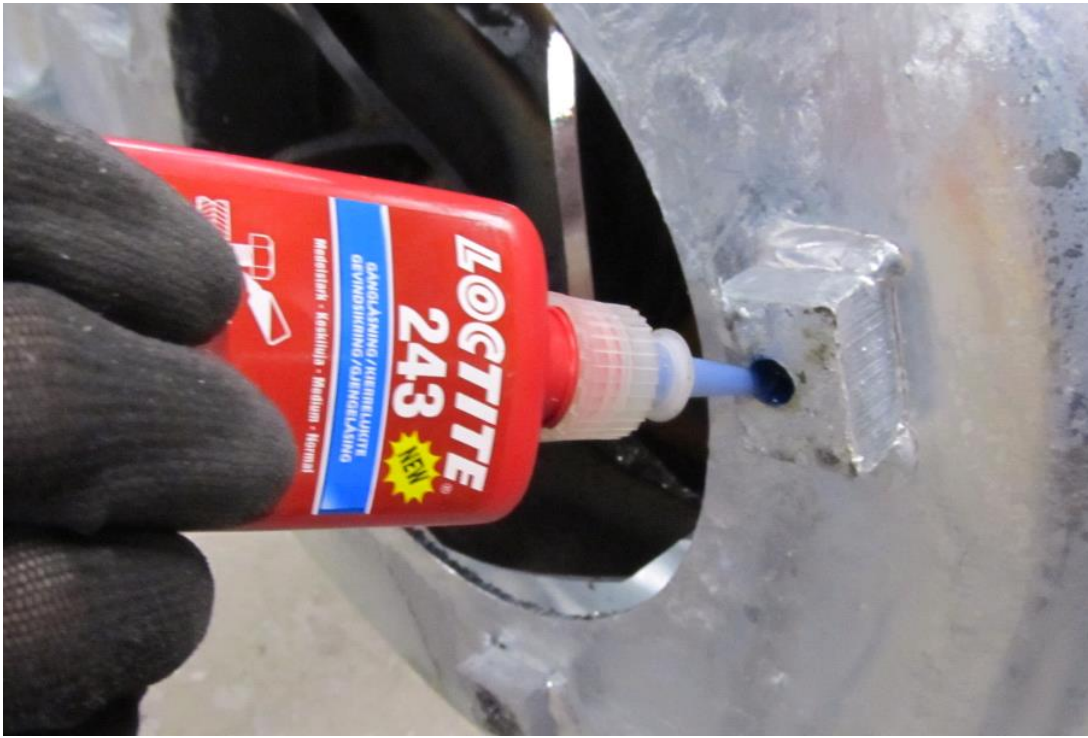
Apply Loctite and attach a new ring.
