Service description

Product: SP400	Service description no: 3125-S004	Ver: 1
-------------------	---	-----------

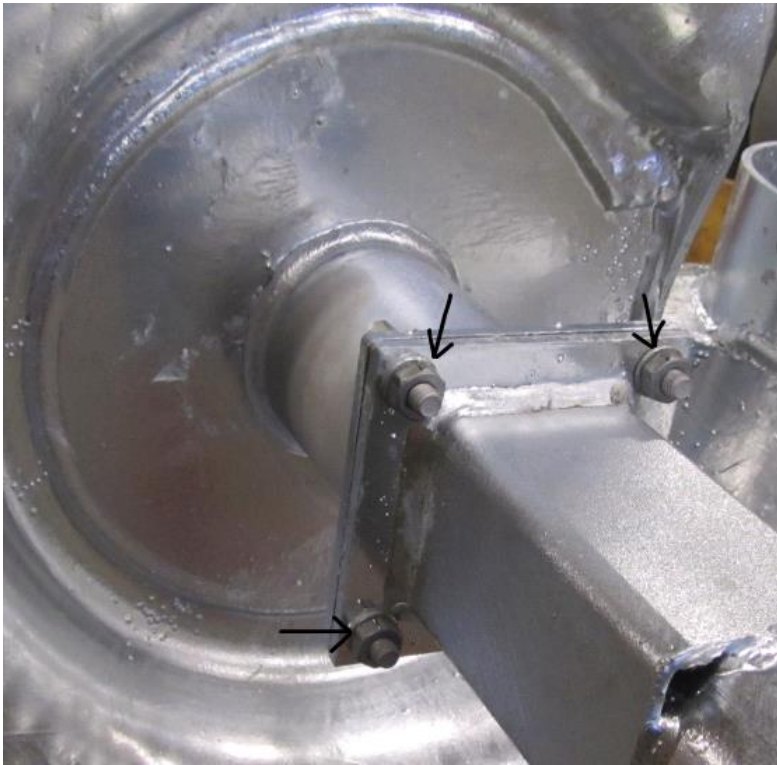
Unscrew the four screws that secure the cover tube to the pump housing.

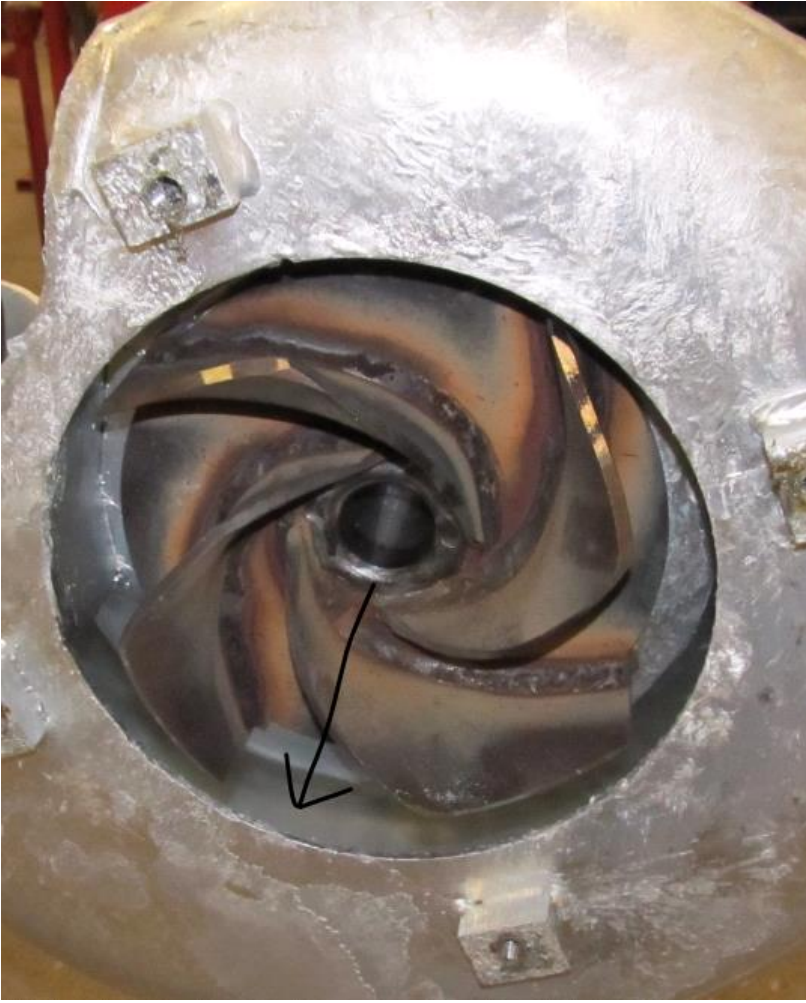
Remove the cutter on the pump housing and pull the impeller out of the pump housing.

Refit the impeller and assemble the pump by following instructions in reverse order.
