Service description

Product: TK105	Service description no: 3311-S001	Ver: 1
-------------------	-----------------------------------------	-----------

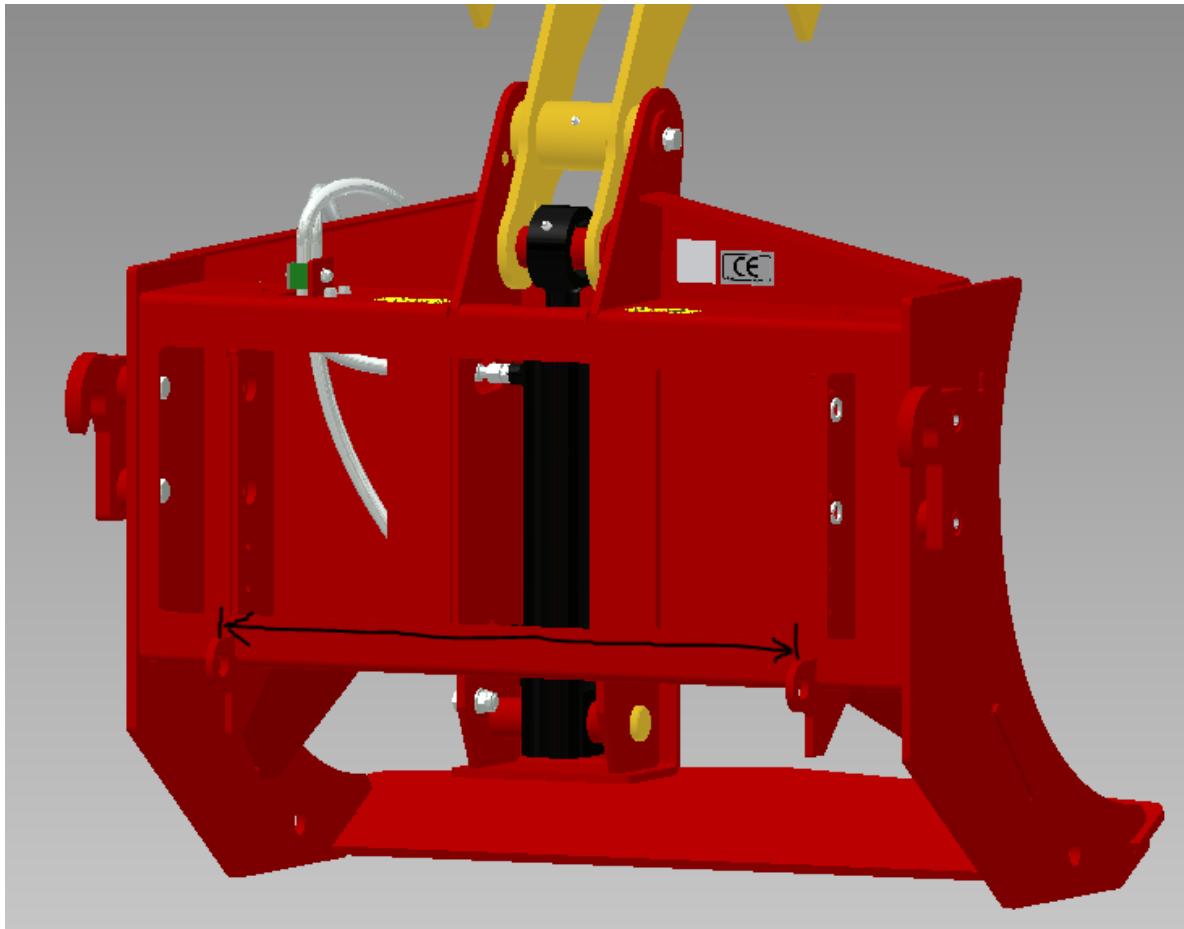
Euro attachment on the claw does not fit on the Lasterramma.

1. The loader has a clean Euro attachment. The distance between locking brackets at the bottom of the claw is too small.
2. The loader has a combined frame with Euro, Trima and Ölø. Euro attachment mounting brackets have too short distance between them.

1. Applies to Timber claw with serial numbers up to 150121.
Cut off the attached brackets and weld them on in the correct position, or buy a claw with a serial number from 150121.
