Service description

| Product: VM420 | Service description No. 4120-S022 | Ver: 1 |

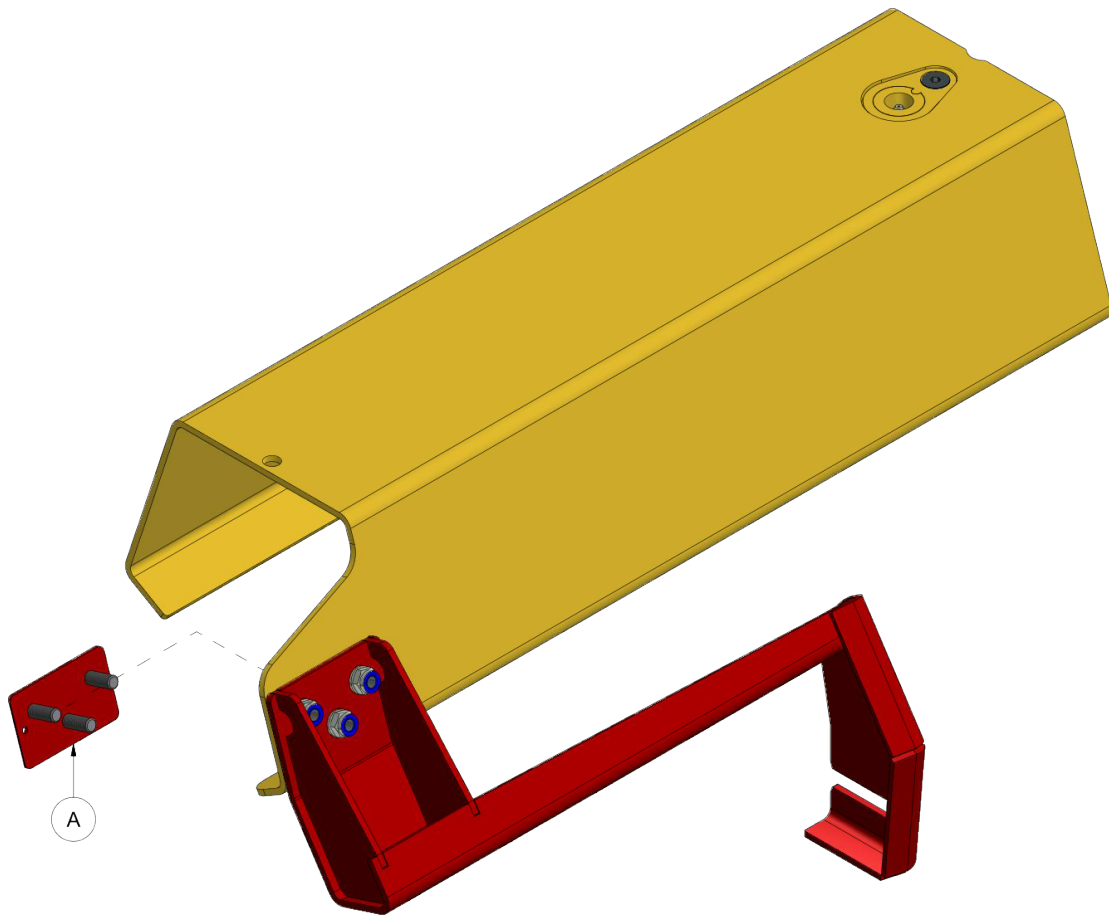
The hydraulic hose connected to the front of splitting cylinder is damaged

1. The valve impulse arm (red item) is fastened with hexagon head screw allowing to little tolerance between splitting ram body and the hydraulic connection.

1. Replace the screws with av bracket (A). This increases the tolerance with 5,5mm.
