Service description

Product: VM420	Service description No: 4120-S024	Ver: 1
-------------------	---	-----------

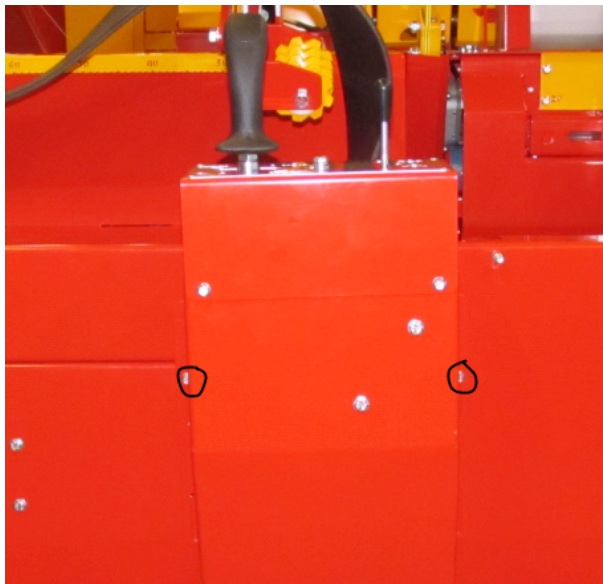
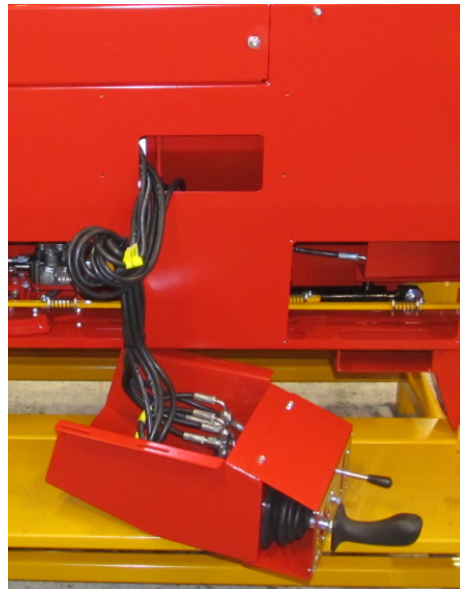
1. Loosen screws attaching the console with joy stick to the chassis. Place the console on the ground carefully..

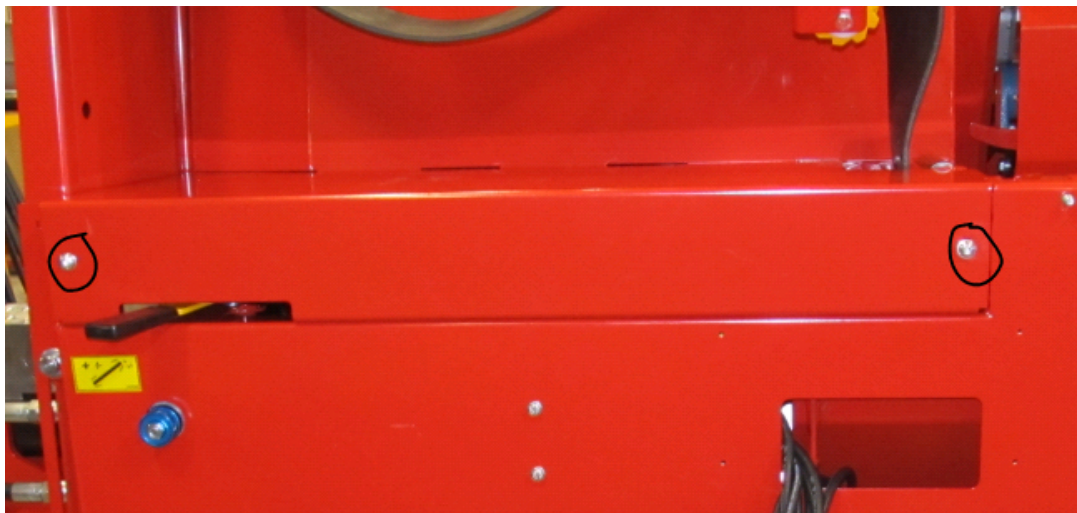
2. Loosen the two indicated screws for the machine table.

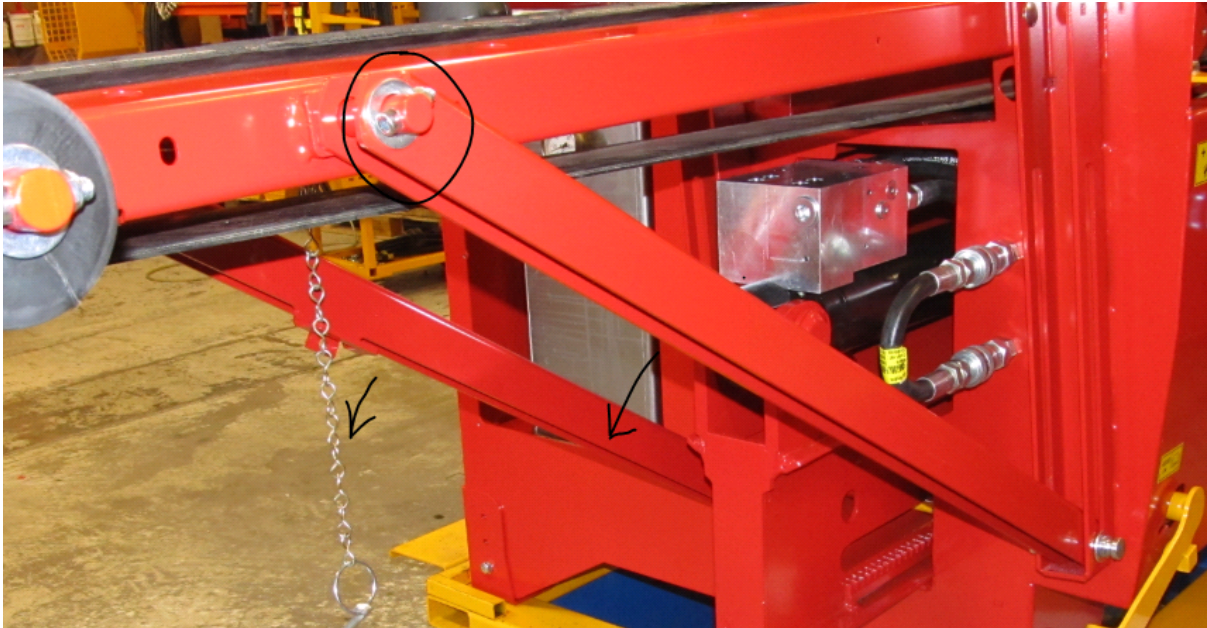
3. Place the feeding table in transport position and lift off the feeding belt at the end roller.

4. Lower the feeding table and dismount the two support legs and lower the end of the feeding table to ground level

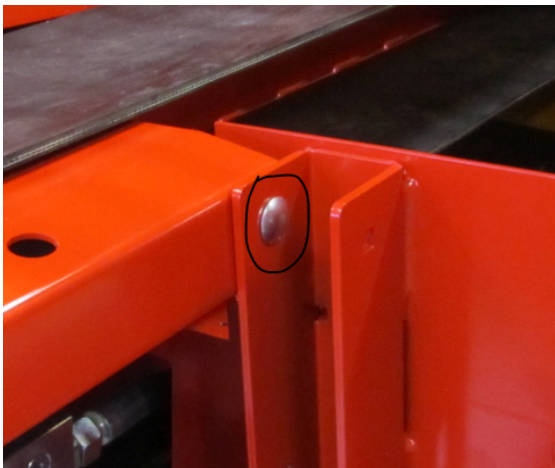
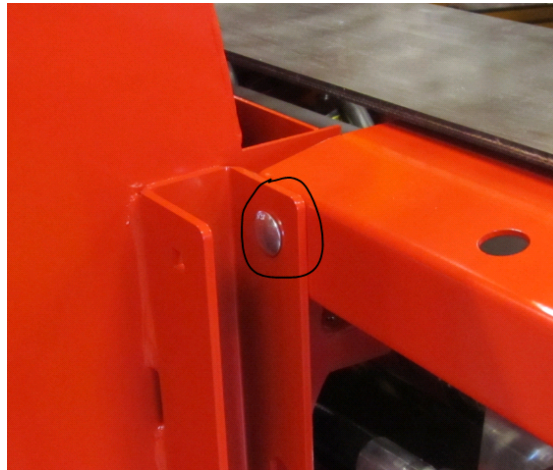
5. Dismount the two screws indicated and remove them. Loosen the feeding belt so that the only obstacle for complete removal now is the drive roller.

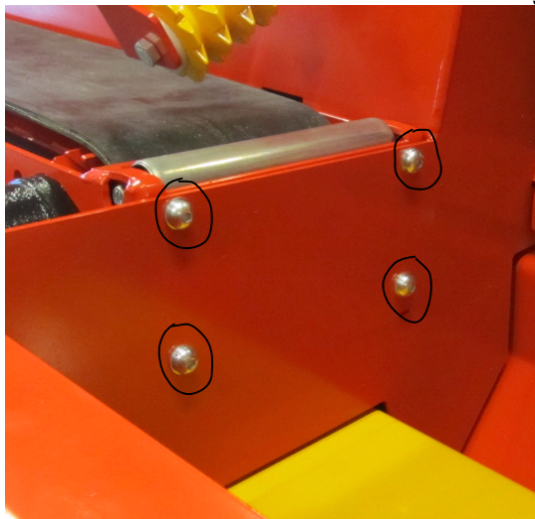
6. Dismount the four marked screws attaching the drive roller bracket. Dismount the bracket allowing access to drive motor and bearing.

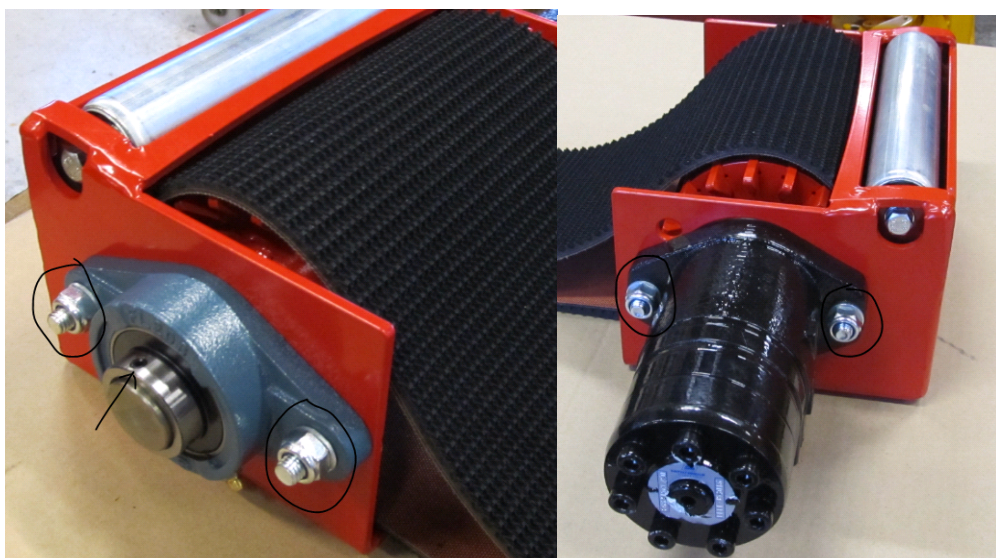
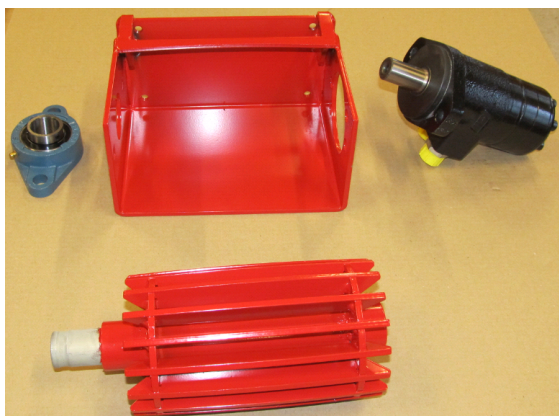
7. Dismount motor and bearing allowing the drive roller to be removed. Remember to loosen the set screw for the bearing as indicated.

8. The feeding belt can then be removed from the machine and a new belt be mounted by performing the procedure backwards.
