Product:	Service description	Ver:
SA1100/1500	^{no:} 2613-M003	1
SA1100/1500	2013-10003

Shafting

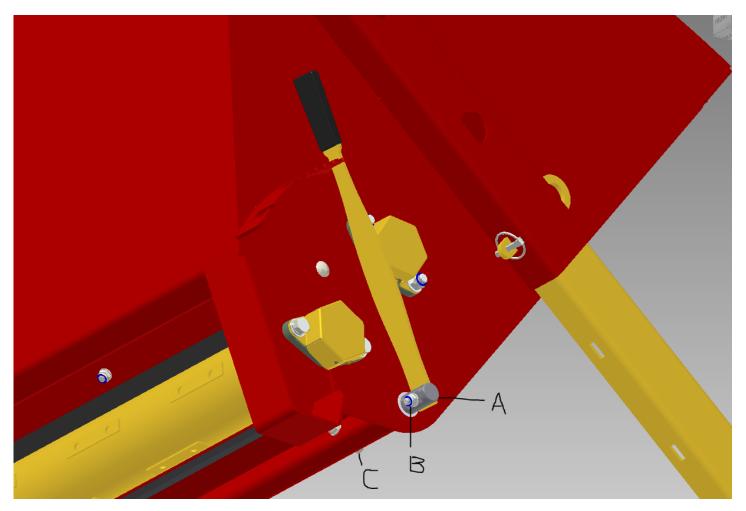
To get more tightening on the sealing hatch, the shaft (A) must be replaced with item number 1261176.

Remove the screws marked (B) and (C) and pull out the shaft. Insert new shaft and reassemble the screws.
