## Service description

Product: SP400	Service description no: 3125-S011	Ver: 1
-------------------	---	-----------

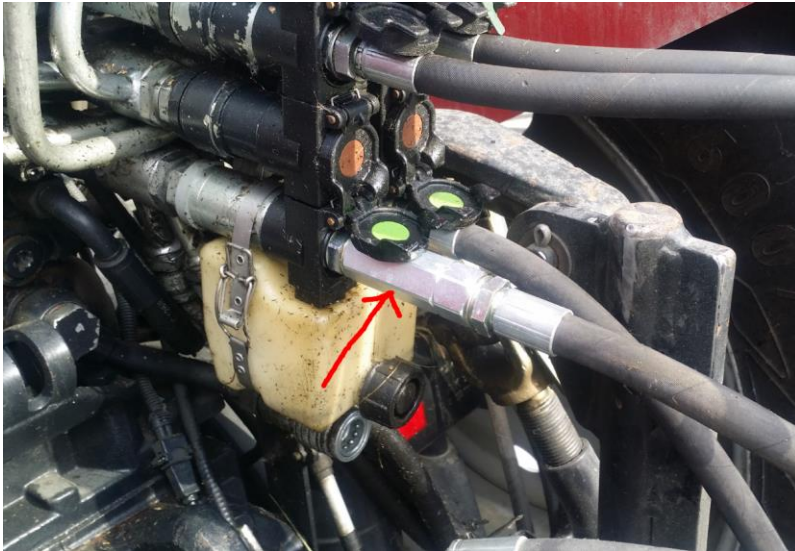
The non-return valve, which prevents pressure being applied to the wrong side of the valve block, does not release when oil pressure has been applied to the wrong hose.

Remove the hose with the non-return valve from the tractor.
