Service description

| Product: VM420 | Service description No.: 4120-S014 | Ver: 1 |

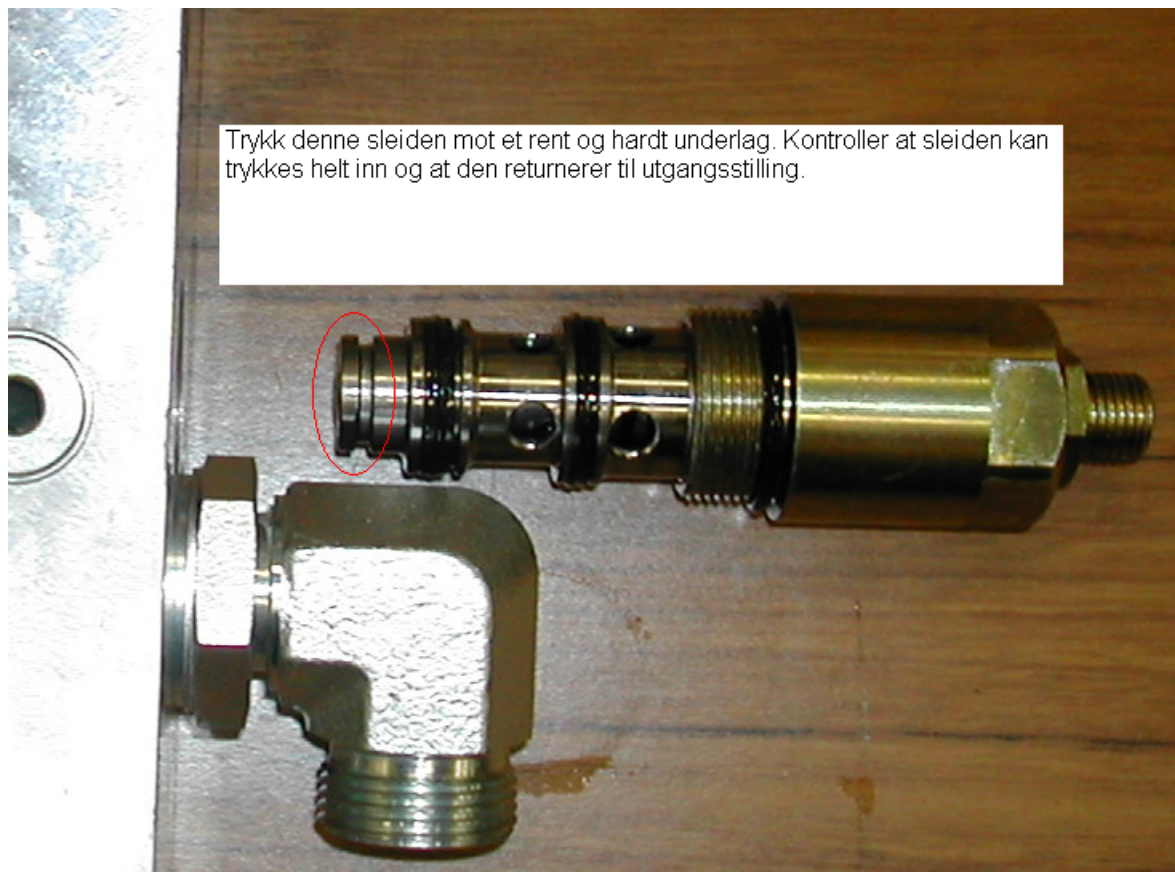
The valve operating this function is a cartridge valve inside the "regenerative" block at the end of the splitting cylinder.

Dismount the cartridge valve and remove eventual contaminants. Check whether the valve can be manually operated by pushing it against a clean and hard surface. Also check all sealings for eventual leakage.

Assemble the valve and test the splitting function.
