## Service description

Product: VM 420	Service description No: 4120-S020	Ver: 1
--------------------	---	-----------

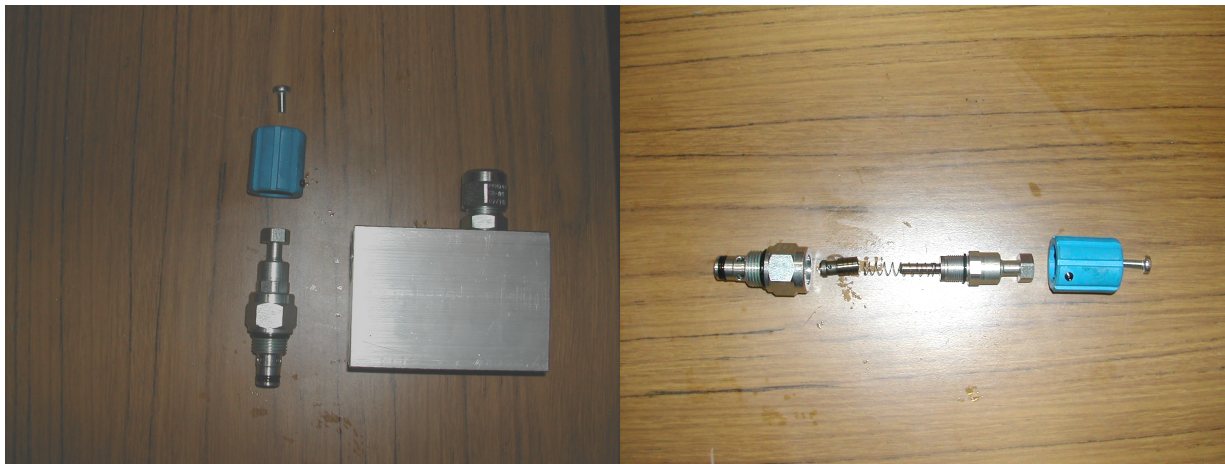
The saw bar does not return after performed cutting, and the saw motor stops as normal.

1. The non return valve regulating the speed of saw movement does not function
2. The plunger for this valve is not functioning.

1. disassemble the valve for speed regulation of saw movement and remove eventual contaminants. You do not need to disassemble the housing (watch picture).

2. Watch [4120-S005](#) (contaminants in valve for saw feed.)
