Service description

Produkt: VM 420	Servicemeldingsnr: 4120-S027	Ver: 1
--------------------	---------------------------------	-----------

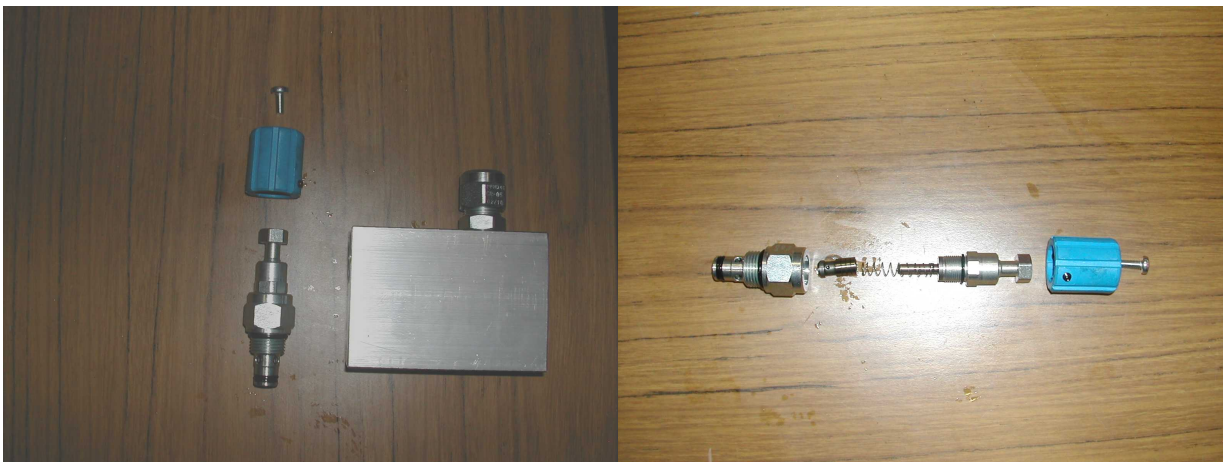
Speed regulation for the saw does not work. Difficult to adjust the speed of the saw
Saw picks and go at different speeds.

Return valve in the control valve for speed not working.

Disassemble valve for speed control of the saw and remove any impurities. The valve body need not be removed. (See picture)
Alternatively, install a new valve into the block.
